# EXISTING CONDITIONS

GUNNISON COUNTY COURTHOUSE FACILITY

17 JULY 2013

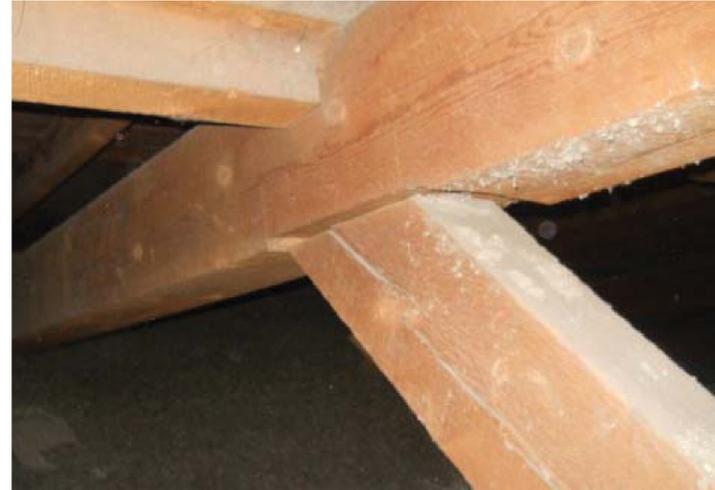
Photo 1, Gap at Truss Joint, Original 1881 Courthouse

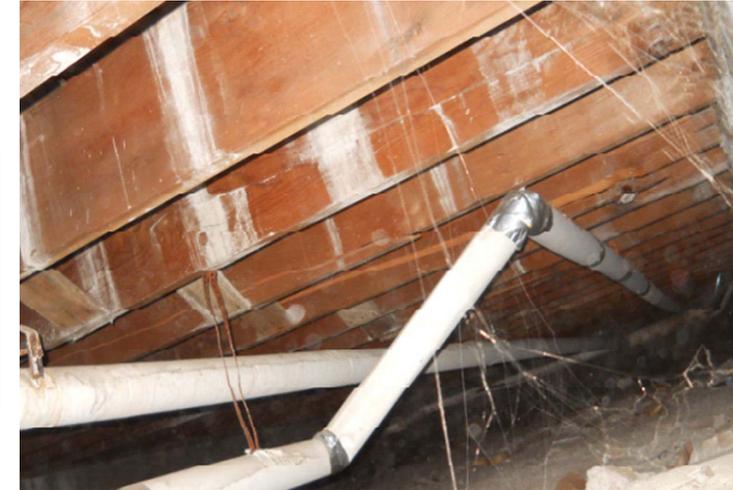
Photo 3, cracked and broken floor joists, Original Jail

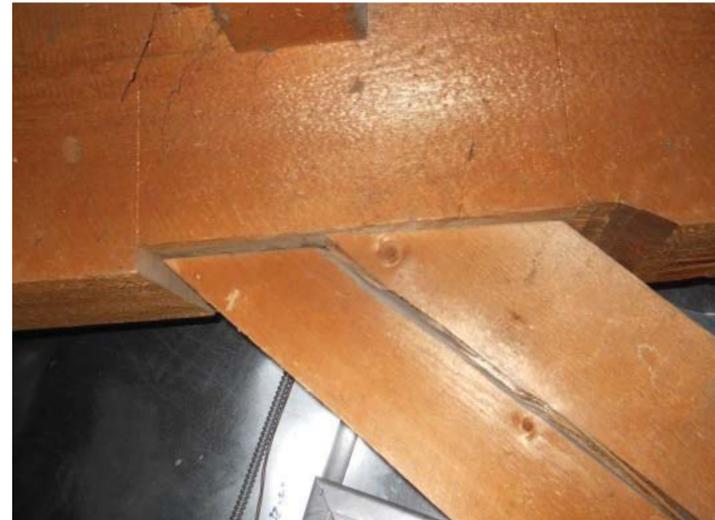
Photo 2, gap at truss joint, Original 1881 Courthouse

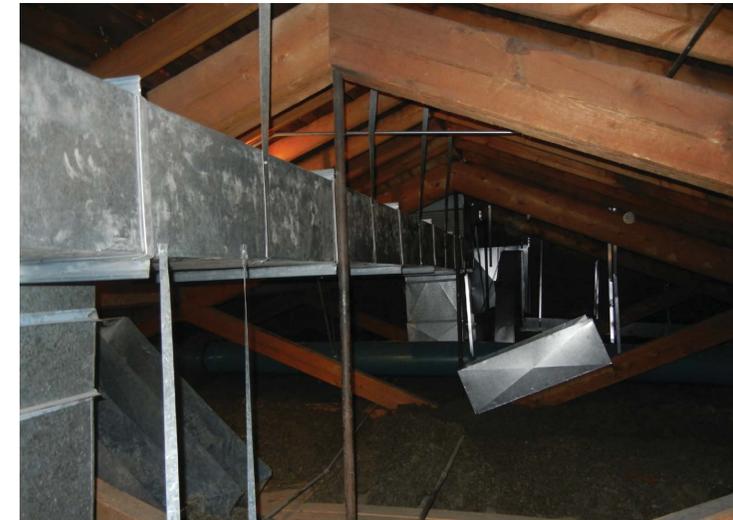
Photo 4, Truss System

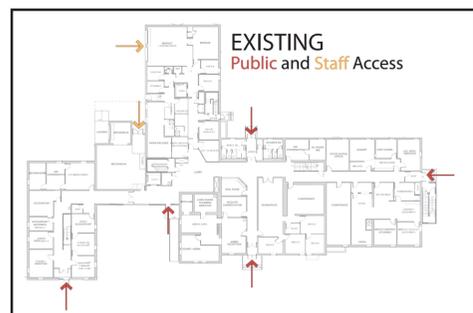
- Renovations and /or new additions required to satisfy needs and update systems will require significant modifications to the current structure and construction type to meet current building and life safety codes.
- Type V construction with assembly occupancy on the second floor requires that all areas be protected by a fire sprinkler system.

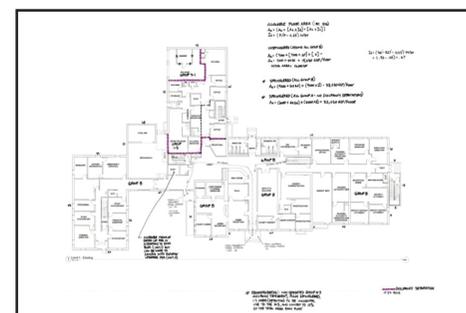
- Current building use no longer has a need for detention occupancy.
- The entire building should be classified A3 and include fire protection per code requirements.

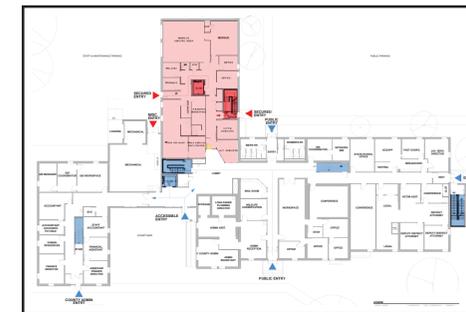
- Existing building exits do not comply with current life safety and accessibility codes.
