**ARCHITECT'S FIELD REPORT**

| <b>PROJECT</b> | <b>Ohio City Town Hall – Phase I</b> | <b>DATE</b> | 9/2/14 |
| | Foundation Stabilization & Electrical Upgrades | <b>TIME</b> | 9:00 am |

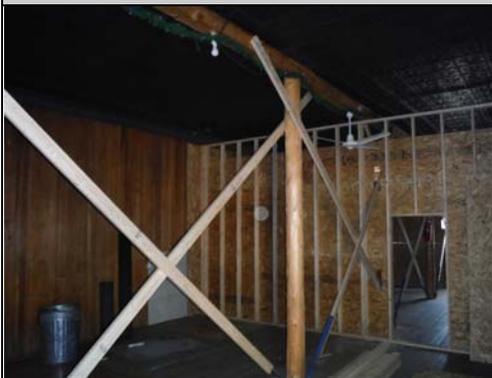
| PHOTO -WORK ITEM | DESCRIPTION | ACTION |
|---|--|---|
| | <p>9/02/14 – Photo 1<br/>Interior Bracing Looking South</p> <p>North, mid-span, and south shear walls are in place.</p> <p>Longitudinal cross bracing is in place.</p> | <p>Note</p> |

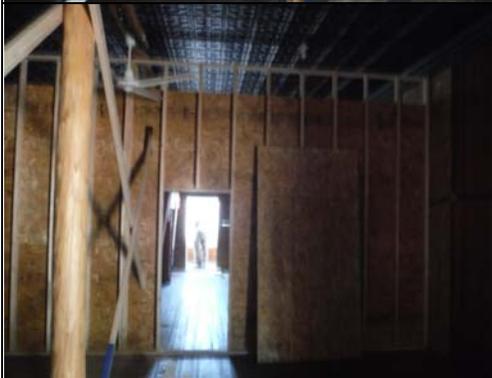
| PHOTO -WORK ITEM | DESCRIPTION | ACTION |
|---|--|---|
| | <p>9/02/14 – Photo 2<br/>Interior Bracing, Mid-Span Shear Wall</p> <p>Detail of shear wall with access opening.</p> | <p>Note</p> |

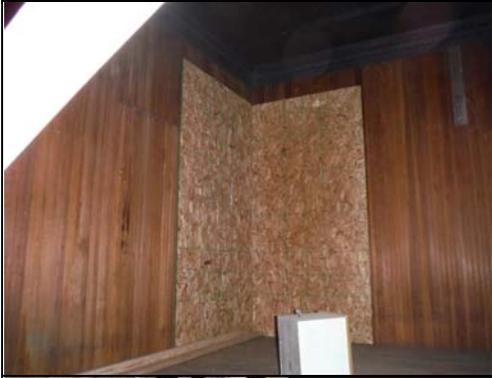
| PHOTO -WORK ITEM | DESCRIPTION | ACTION |
|---|--|---|
| | <p>9/02/14 – Photo 3<br/>Interior Bracing, Northeast Corner</p> <p>4x8 OSB shear panels installed in the northeast and northwest corners.</p> | <p>Note</p> |

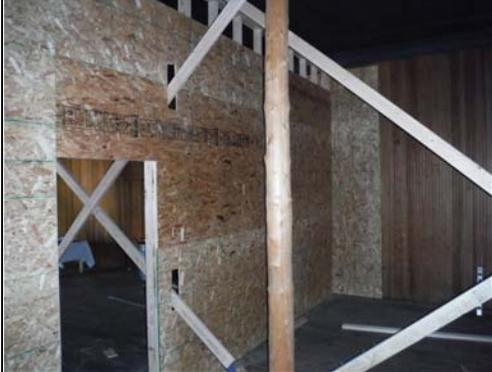
| PHOTO -WORK ITEM | DESCRIPTION | ACTION |
|---|--|---|
| | <p>9/02/14 – Photo 4<br/>Interior Bracing, Mid-Span Shear Wall</p> <p>Detail of the north elevation of the shear wall. OSB sheathing has been installed at the junction with the existing exterior wall.</p> | <p>Note</p> |

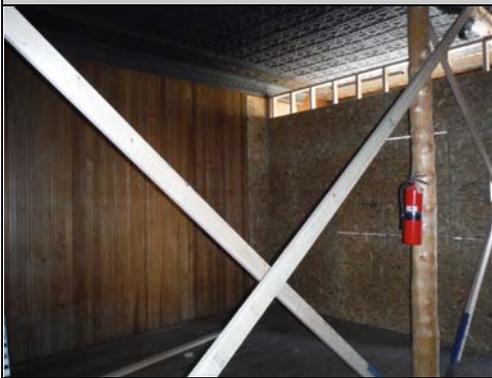
| PHOTO -WORK ITEM | DESCRIPTION | ACTION |
|---|--|---|
| | <p>9/02/14 – Photo 5<br/>Interior Bracing, Cross-Bracing</p> | <p>Note</p> |

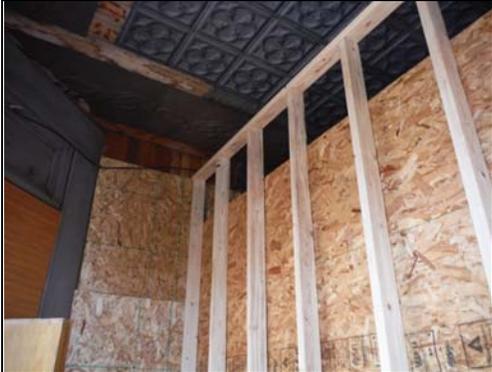
| PHOTO -WORK ITEM | DESCRIPTION | ACTION |
|---|--|---|
| | <p>9/02/14 – Photo 6<br/>Interior Bracing, South Shear Wall<br/><br/>Head condition of perpendicular wall joint.</p> | <p>Note</p> |

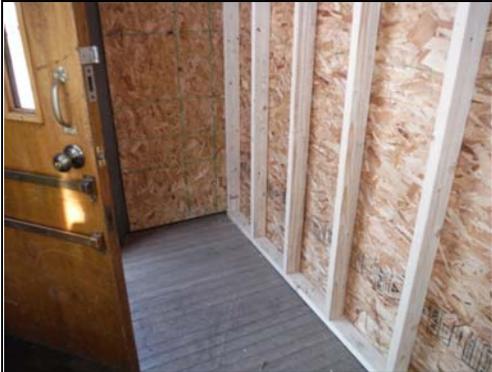
| PHOTO -WORK ITEM | DESCRIPTION | ACTION |
|---|--|---|
| | <p>9/02/14 – Photo 7<br/>Interior Bracing, South Shear Wall<br/><br/>Base condition of perpendicular wall joint.</p> | <p>Note</p> |

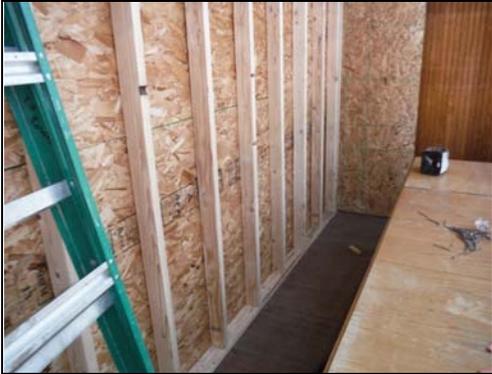
| PHOTO -WORK ITEM | DESCRIPTION | ACTION |
|---|--|---|
| | <p>9/02/14 – Photo 8<br/>Interior Bracing, South Shear Wall<br/><br/>Base condition of perpendicular wall joint.</p> | <p>Note</p> |

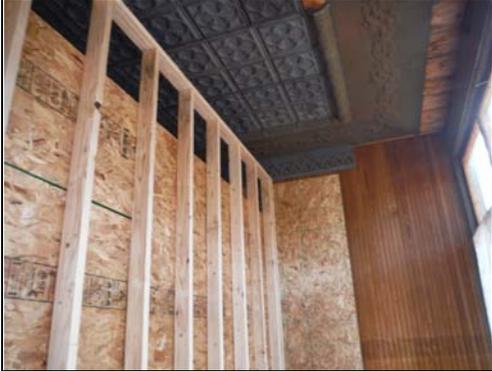
| PHOTO -WORK ITEM | DESCRIPTION | ACTION |
|---|--|---|
| | <p>9/02/14 – Photo 9<br/>Interior Bracing, South Shear Wall</p> <p>Head condition of perpendicular wall joint.</p> | <p>Note</p> |

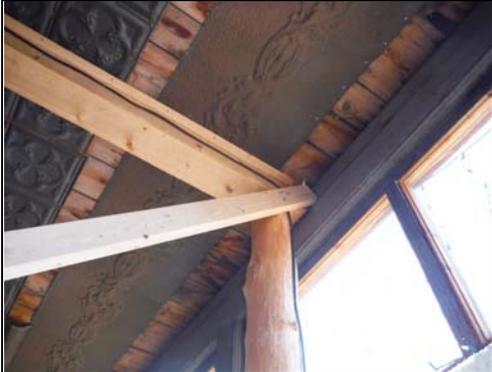
| PHOTO -WORK ITEM | DESCRIPTION | ACTION |
|---|--|---|
| | <p>9/02/14 – Photo 10<br/>Interior Bracing, South Cross Bracing</p> <p>Detail of cross bracing connection at beam and column.</p> | <p>Note</p> |

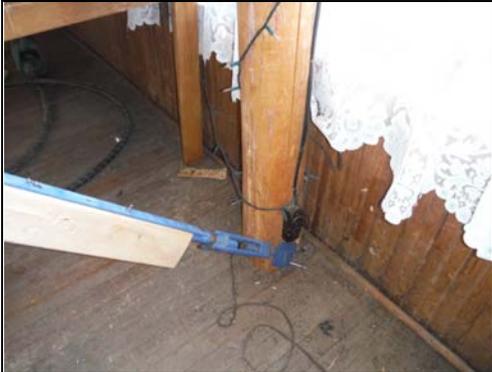
| PHOTO -WORK ITEM | DESCRIPTION | ACTION |
|---|--|---|
| | <p>9/02/14 – Photo 11<br/>Interior Bracing, South Cross Bracing</p> <p>Detail of base connection.</p> | <p>Note</p> |

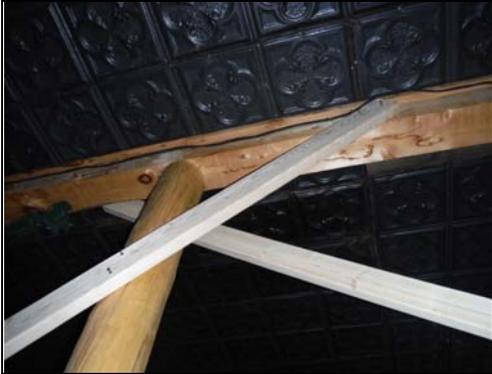
| PHOTO -WORK ITEM | DESCRIPTION | ACTION |
|---|--|---|
| | <p>9/02/14 – Photo 12<br/>Interior Bracing, Cross Bracing</p> <p>Cross bracing connection at mid-span.</p> <p>Additional gusset bracing may be required.</p> | <p>TVC</p> |

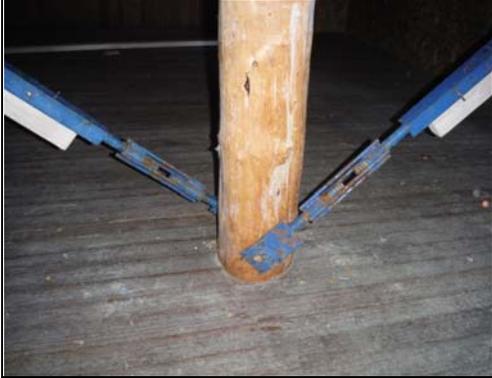
| PHOTO -WORK ITEM | DESCRIPTION | ACTION |
|---|--|---|
| | <p>9/02/14 – Photo<br/>Interior Bracing, Column 2 Base</p> <p>Additional column base supports may be required.</p> | <p>TVC</p> |

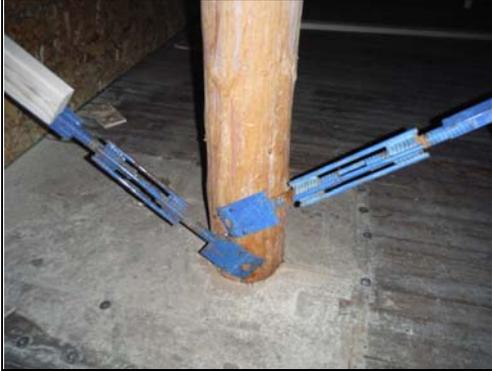
| PHOTO -WORK ITEM | DESCRIPTION | ACTION |
|---|--|---|
| | <p>9/02/14 – Photo<br/>Interior Bracing, Column 3 Base</p> <p>Additional column base supports may be required.</p> | <p>TVC</p> |

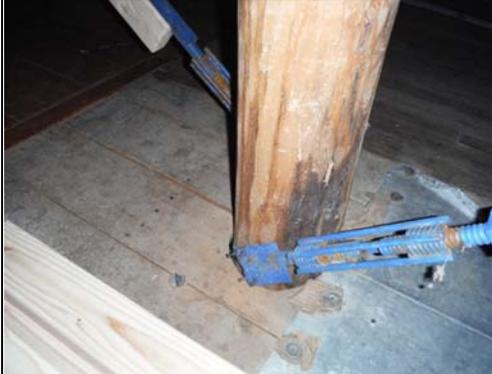
| PHOTO -WORK ITEM | DESCRIPTION | ACTION |
|---|--|---|
| | <p>9/02/14 – Photo<br/>Interior Bracing, Column 4 Base</p> <p>Additional column base supports may be required.</p> | <p>TVC</p> |

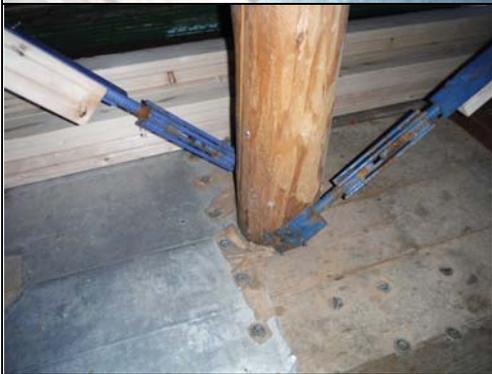
| PHOTO -WORK ITEM | DESCRIPTION | ACTION |
|---|--|---|
| | <p>9/02/14 – Photo<br/>Interior Bracing, Column 5 Base</p> <p>Additional column base supports may be required.</p> | <p>TVC</p> |
