ARCHITECT'S FIELD REPORT

PROJECT	Ohio City Town Hall Interior and Exterior Rehabilitation, Phase II SHF Project # 2017-01-021	DATE	9/13/2017
----------------	---	-------------	-----------

WORK OBSERVED	
Window & Door Installation and Paint Colors	
TRADES PRESENT	
None

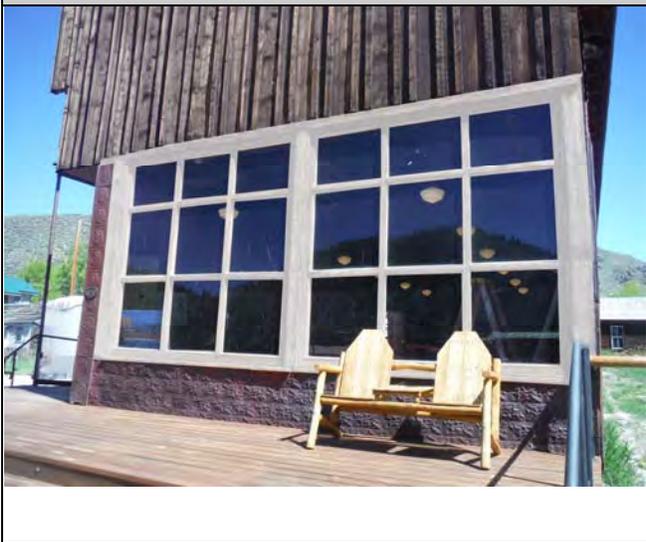
<p>9/9/17 – Mock-Up Photo 1</p> <p>Photo rendering shows the storefront windows painted in the same color as the existing interior trim, color match SW 6233 “Samovar Silver.”</p> <p><i>While the storefront windows may have been painted at one time, the paint finish was deemed inappropriate as it does not match the current historic character.</i></p>	<p>Note</p>

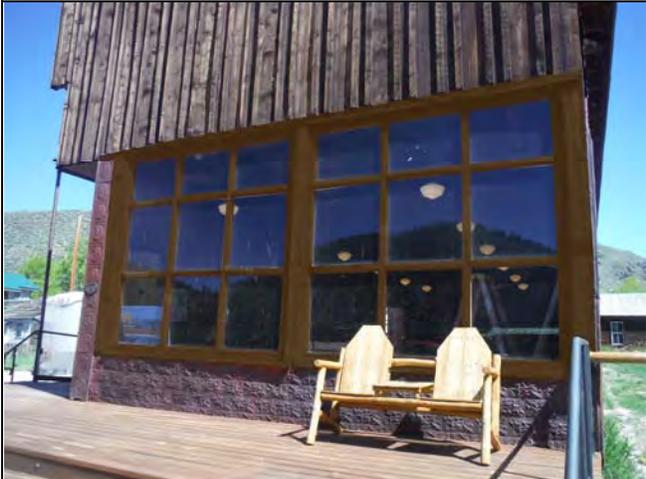
<p>9/9/17 – Mock-Up Photo 2</p> <p>Photo rendering shows the storefront windows painted in the same color as the existing interior side door, color match SW 6013 “Bitter Chocolate.”</p> <p><i>Again, this was not the recommended finish due to the effects on the historic character of the building.</i></p>	<p>Note</p>

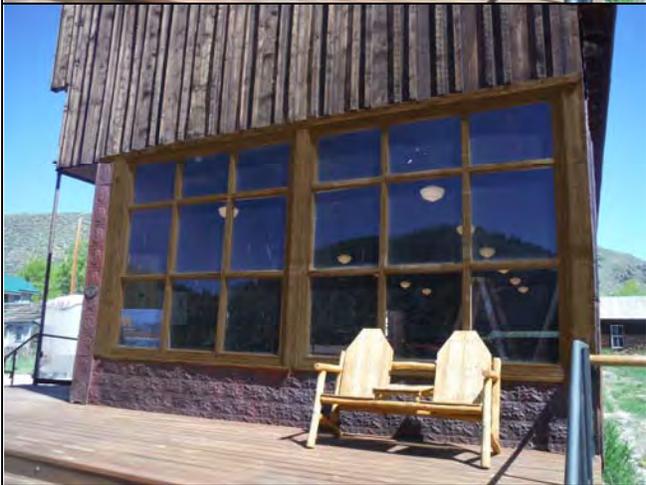
<p>9/9/17 – Mock-Up Photo 3</p> <p>Photo rendering shows the storefront windows treated with an exterior wood preservative. The coloration of the wood is slightly darker.</p> <p><i>It was determined that this was the appropriate exterior finish for both preservation and long term maintenance.</i></p>	<p>Note</p>

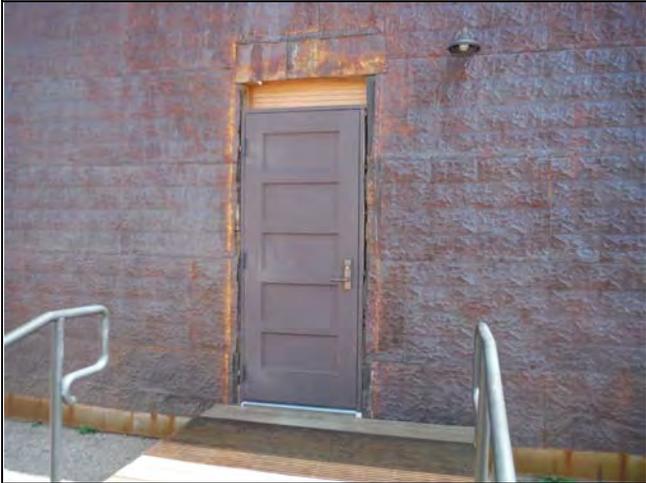
<p>9/9/17 – Photo 1</p> <p>Recreated 5-panel side door has been installed and painted trim color match SW 6013 “Bitter Chocolate.” The transom window above has not been installed.</p>	<p>Note</p>

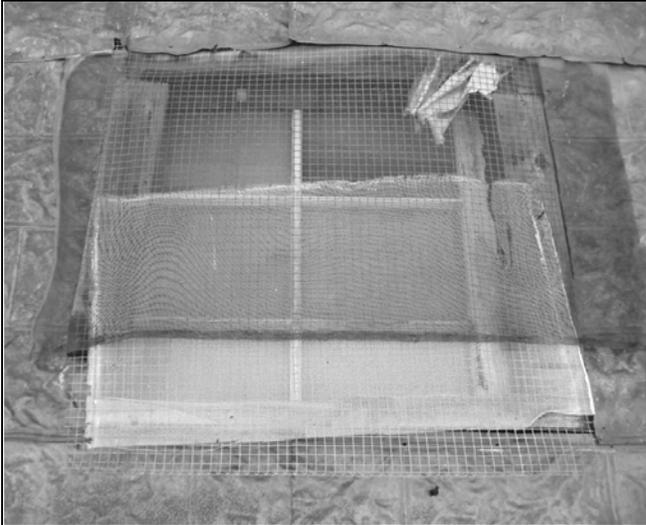
<p>9/9/17 – Photo 2</p> <p>Existing conditions photo taken in 2012 which was used to recreate the divided light pattern of the new windows.</p>	<p>Note</p>

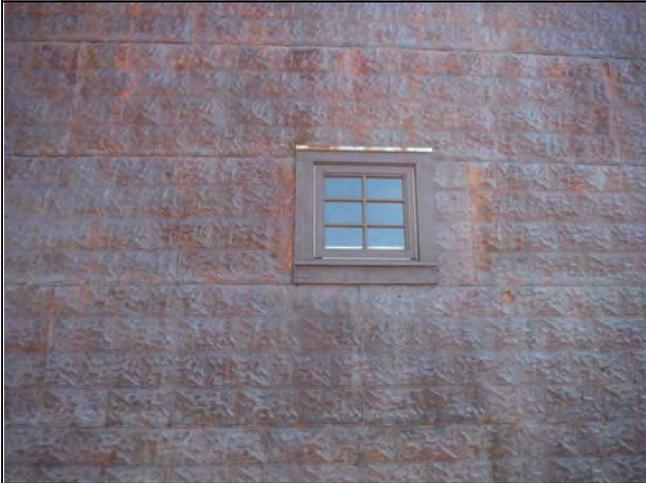
<p>9/9/17 – Photo 3</p> <p>Window and window trim installed. The window has been painted trim color match SW 6013 “Bitter Chocolate.”</p> <p>Flashing at the head of the window is cold-rolled steel and has begun to patina.</p>	<p>Note</p>

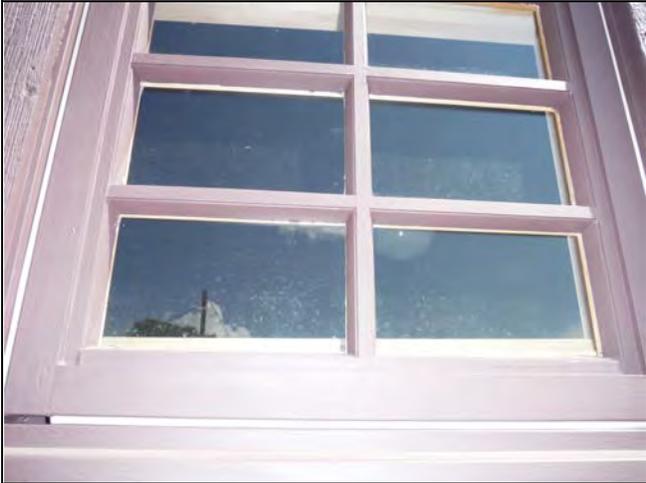
<p>9/9/17 – Photo 4</p> <p>Detail of the side window muntins.</p> <p><i>Review of the muntin width by the SHF is requested.</i></p>	<p>Note</p>

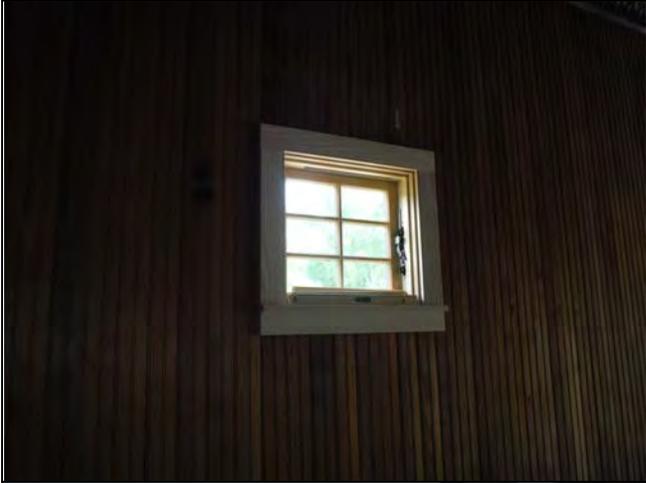
<p>9/9/17 – Photo 5</p> <p>Side window as seen from the interior. The awning crank is visible on the right jamb. A cover over the crank has not been installed.</p> <p>Interior trim has been set.</p> <p>Interior finish has not been determined.</p>	<p>Note</p>

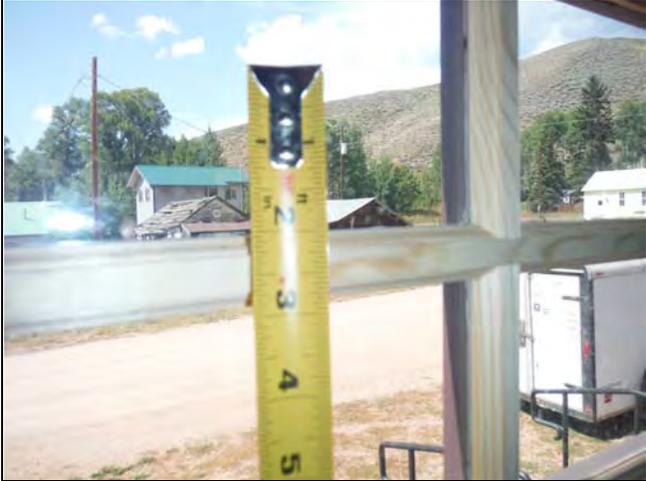
<p>9/9/17 – Photo 6</p> <p>Detail of the window muntin on the installed window. The width is 7/8".</p> <p><i>Review of the muntin width by the SHF is requested.</i></p> <p>Interior finish has not been determined.</p>	<p>Note</p>

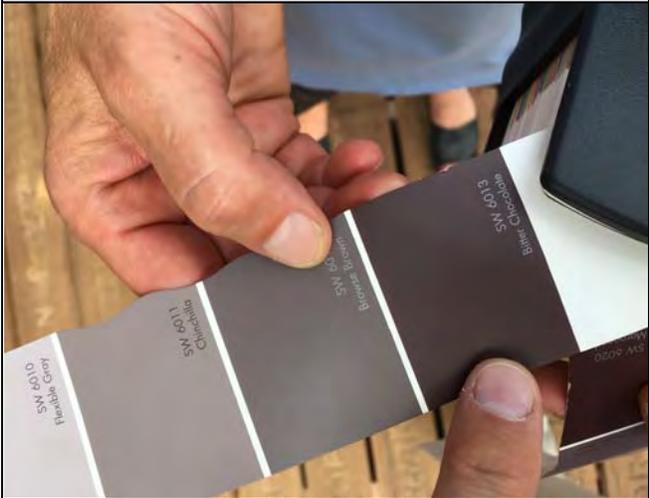
<p>9/9/17 – Photo 7</p> <p>Detail of color swatch used to match the existing side door paint color.</p> <p>The approximate color match is SW 6013 “Bitter Chocolate.”</p>	<p>Note</p>

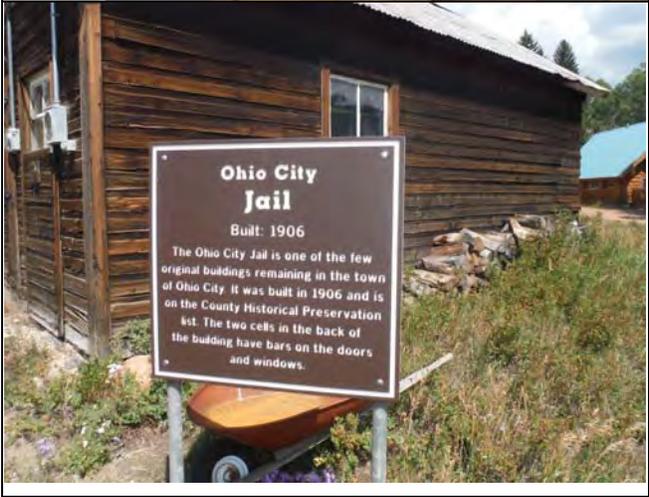
<p>9/9/17 – Photo 8</p> <p>Example window photos taken from the Ohio City Jail constructed at approximately the same time.</p>	<p>Note</p>

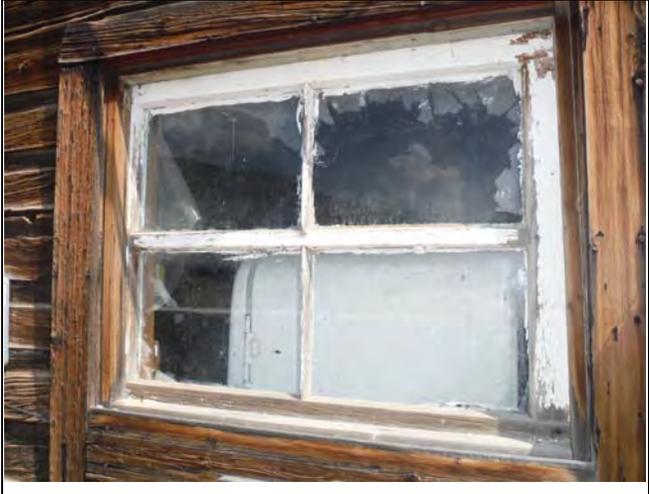
<p>9/9/17 – Photo 9</p> <p>Ohio City Jail, Front Window.</p> <p>The window is a 4-Light with a wide horizontal member measuring approximately 1-1/4” wide and thin vertical member measuring approximately 1/2” wide.</p>	<p>Note</p>

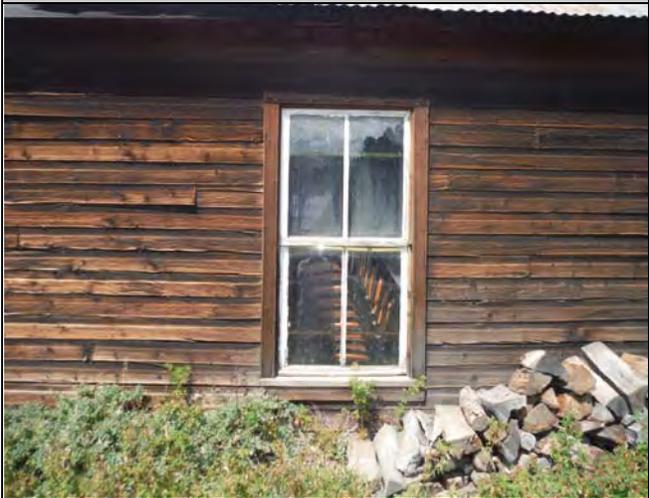
<p>9/9/17 – Photo 10</p> <p>Ohio City Jail, Side Window.</p> <p>The window is a 4-Light single hung with a single</p>	<p>Note</p>

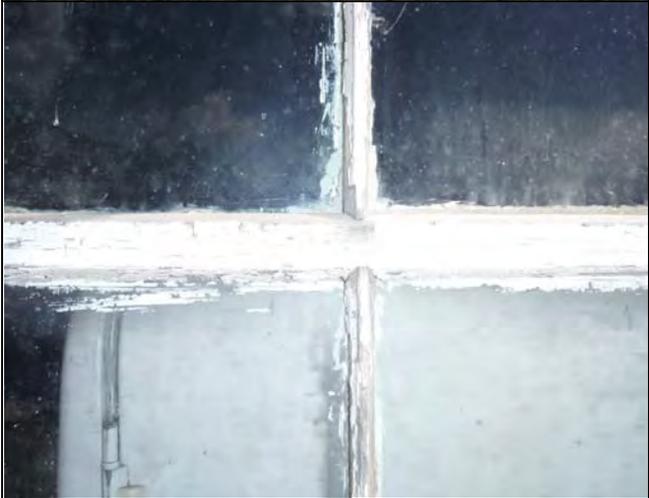
<p>9/9/17 – Photo 11</p> <p>Detail of the front window muntin. The horizontal member measures approximately 1-1/4" wide and vertical member measures approximately 1/2" wide.</p>	<p>Note</p>

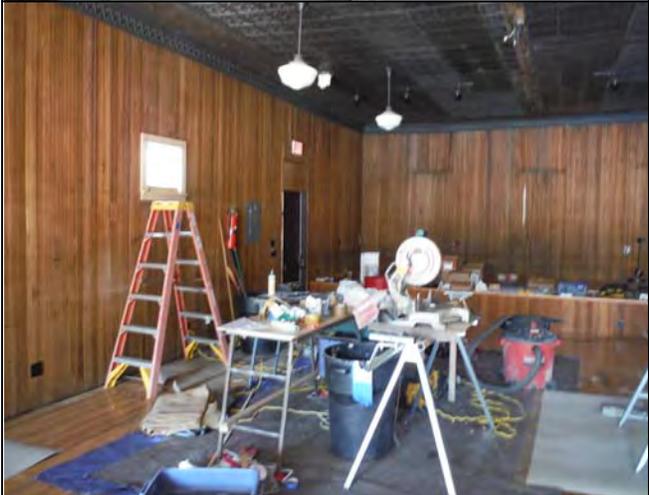
<p>9/9/17 – Photo 12</p> <p>Interior photo of the Town Hall. The side windows add natural light to the back of the otherwise dark building.</p>	<p>Note</p>
