ARCHITECT'S FIELD REPORT

02

| PROJECT | Ohio City Town Hall Interior and Exterior Rehabilitation, Phase II SHF Project # 2017-01-021 | DATE | 9/13/2017 |

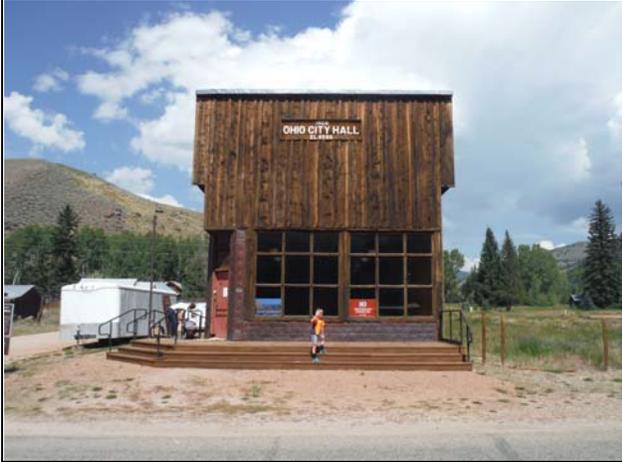
| PHOTO – WORK ITEM | DESCRIPTION | ACTION |
|---|---|---|
| | <p>9/9/17 – Photo 1</p> <p>South Elevation View. Wood preservative treatment has been applied to the board and batten siding and storefront window frame. Lettering has been repainted.</p> | <p>Note</p> |

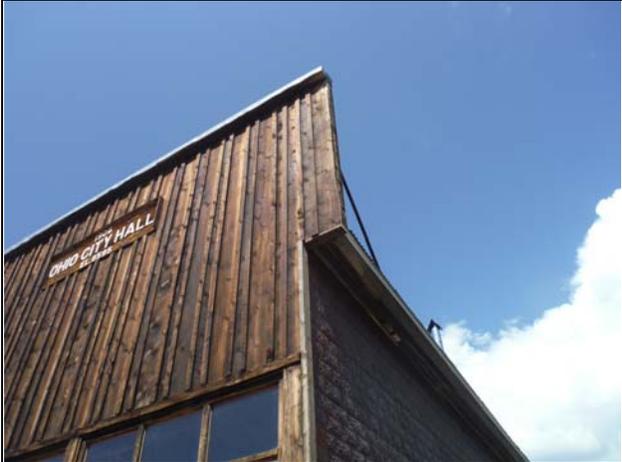
| PHOTO – WORK ITEM | DESCRIPTION | ACTION |
|---|---|---|
| | <p>9/9/17 – Photo 2</p> <p>Southeast Corner Detail 1. Note wood preservative treatment and recreated wood corner trim.</p> | <p>Note</p> |

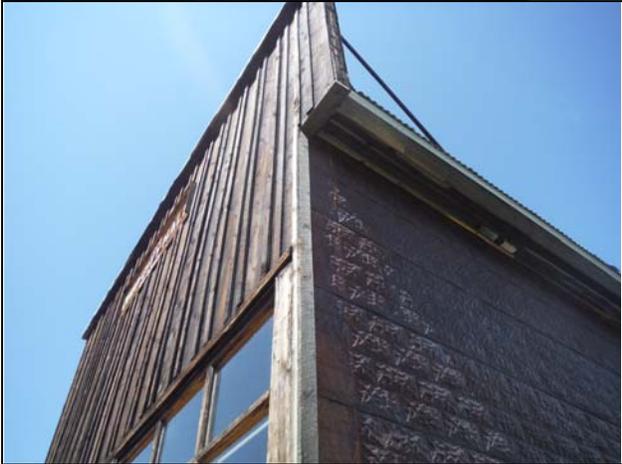
| PHOTO – WORK ITEM | DESCRIPTION | ACTION |
|---|---|---|
| | <p>9/9/17 – Photo 3</p> <p>Southeast Corner Detail 2. Note wood preservative treatment and recreated wood corner trim.</p> | <p>Note</p> |

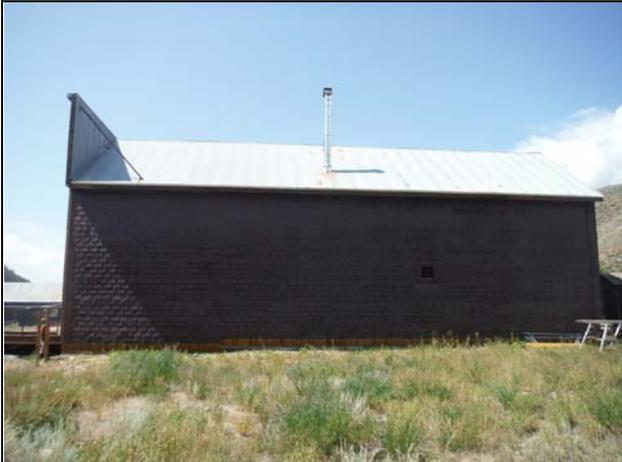
| PHOTO – WORK ITEM | DESCRIPTION | ACTION |
|---|---|---|
| | <p>9/9/17 – Photo 4</p> <p>East Elevation. Metal wall panels have been realigned.</p> | <p>Note</p> |

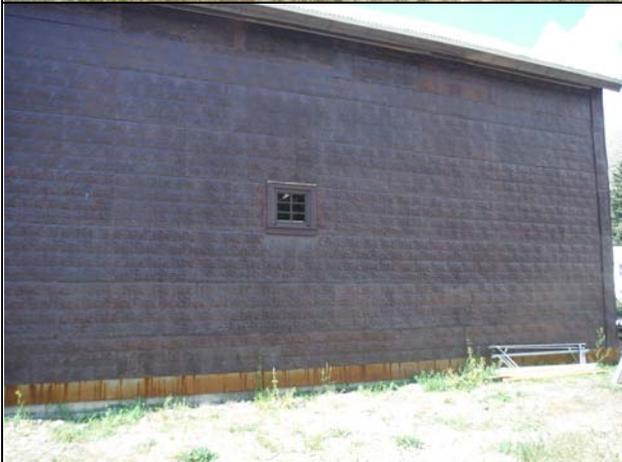
| PHOTO – WORK ITEM | DESCRIPTION | ACTION |
|---|---|---|
| | <p>9/9/17 – Photo 5</p> <p>East Elevation Detail. Side window and trim have been installed for review.</p> <p>Metal base and vents have been installed. Natural patina has begun.</p> | <p>Note</p> |

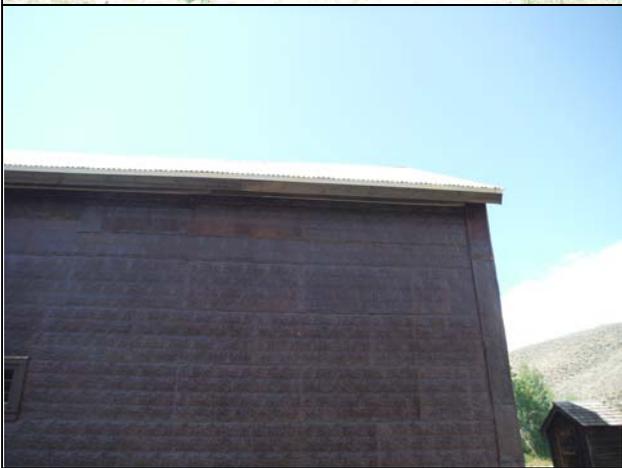
| PHOTO – WORK ITEM | DESCRIPTION | ACTION |
|---|---|---|
| | <p>9/9/17 – Photo 6</p> <p>East Elevation Detail. Back corner trim has been relocated. Note the metal panels have been carefully realigned at the top right corner.</p> | <p>Note</p> |

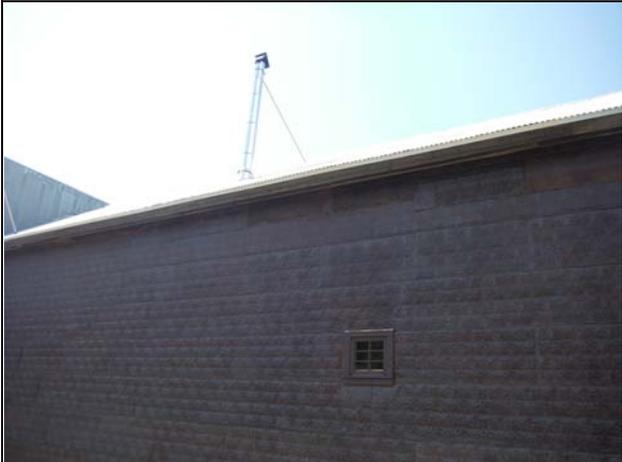
| PHOTO – WORK ITEM | DESCRIPTION | ACTION |
|---|---|---|
| | <p>9/9/17 – Photo 7</p> <p>East Elevation Looking South. Metal panels have been realigned.</p> | <p>Note</p> |

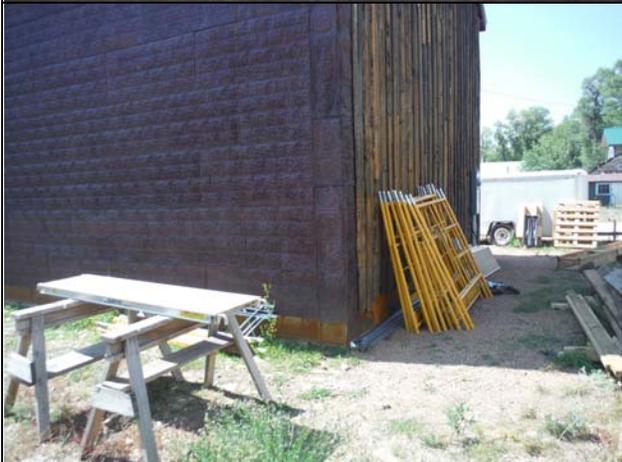
| PHOTO – WORK ITEM | DESCRIPTION | ACTION |
|---|---|---|
| | <p>9/9/17 – Photo 8</p> <p>East Elevation Corner Detail 1. Metal corner trim has been realigned. New metal base extends around the north elevation.</p> | <p>Note</p> |

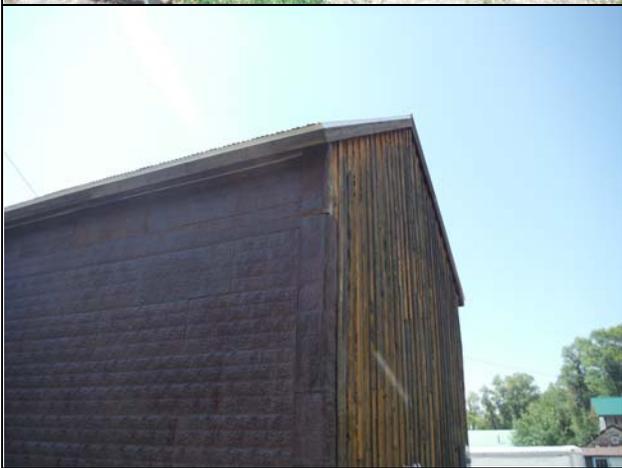
| PHOTO – WORK ITEM | DESCRIPTION | ACTION |
|---|---|---|
| | <p>9/9/17 – Photo 9</p> <p>East Elevation Corner Detail 2. The relocated corner trim extends to the roof eave.</p> | <p>Note</p> |

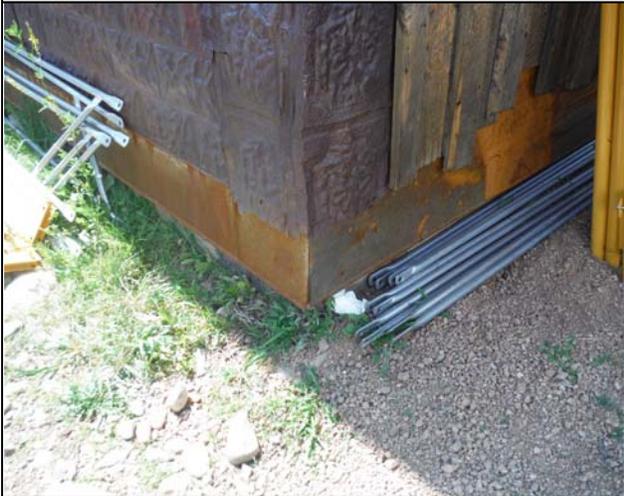
| PHOTO – WORK ITEM | DESCRIPTION | ACTION |
|---|--|---|
| | <p>9/9/17 – Photo 10</p> <p>Detail of the metal base at the northeast corner. The metal base will protect the bottom portion of the foundation from snow buildup and disguises the crawlspace ventilation.</p> | <p>Note</p> |

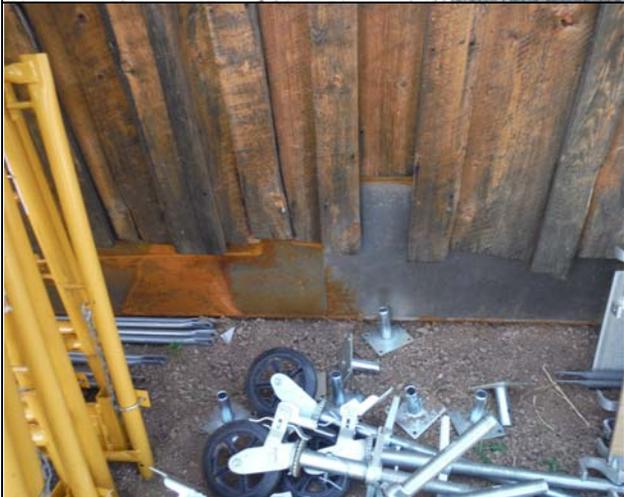
| PHOTO – WORK ITEM | DESCRIPTION | ACTION |
|---|--|---|
| | <p>9/9/17 – Photo 11</p> <p>Detail of the metal base at the north elevation.</p> | <p>Note</p> |

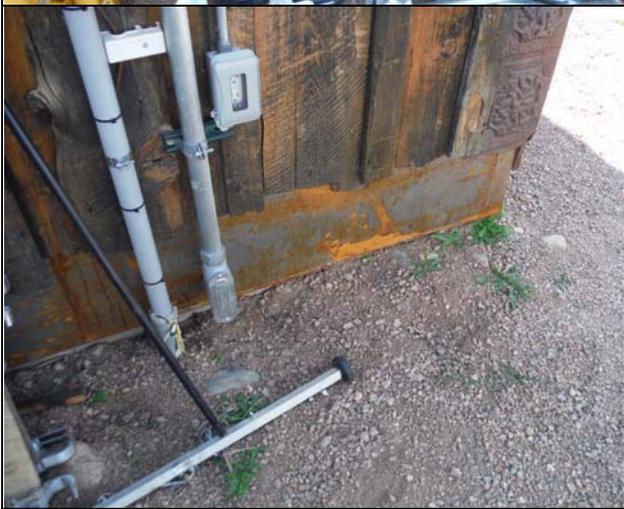
| PHOTO – WORK ITEM | DESCRIPTION | ACTION |
|---|--|---|
| | <p>9/9/17 – Photo 12</p> <p>Detail of the metal base at the north elevation. The cold-rolled steel should patina to match the historic metal siding.</p> | <p>Note</p> |

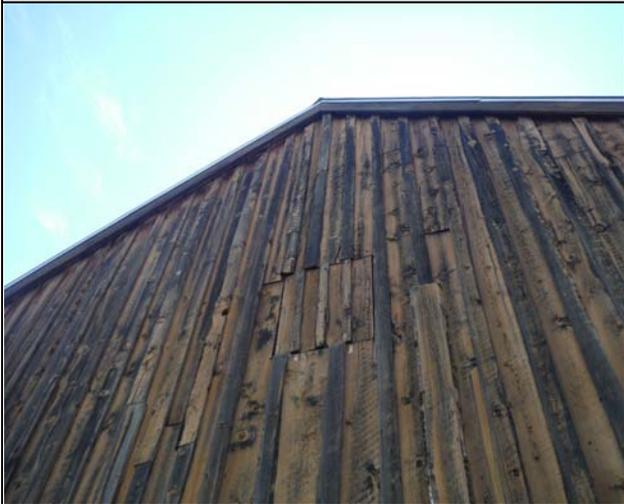
| PHOTO – WORK ITEM | DESCRIPTION | ACTION |
|---|--|---|
| | <p>9/9/17 – Photo 13</p> <p>North Elevation Gable End. Wood preservative treatment has been applied to the board and batten siding.</p> | <p>Note</p> |

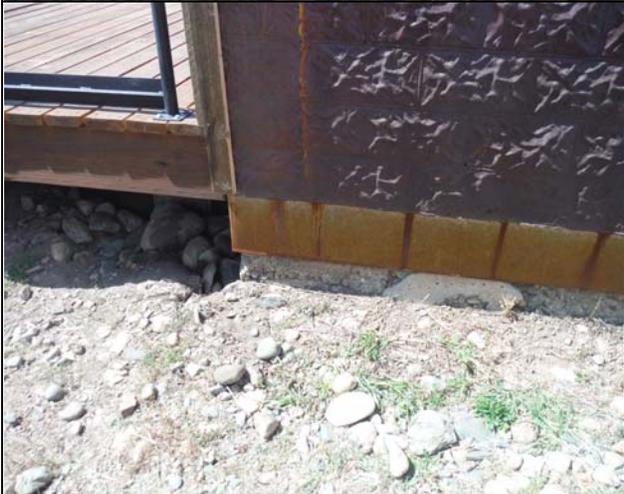
| PHOTO – WORK ITEM | DESCRIPTION | ACTION |
|---|--|---|
| | <p>9/9/17 – Photo 14</p> <p>Detail of the Southeast Elevation. Additional metal base has been installed to cover the box beam foundation in this location.</p> | <p>Note</p> |

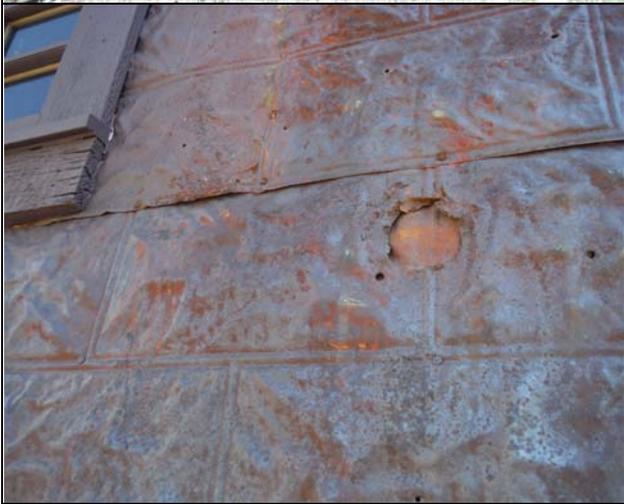
| PHOTO – WORK ITEM | DESCRIPTION | ACTION |
|---|--|---|
| | <p>9/9/17 – Photo 15</p> <p>West Elevation Detail. Detail of hole that has been patched with rusted metal. (Previous electrical service entry.)</p> | <p>Note</p> |

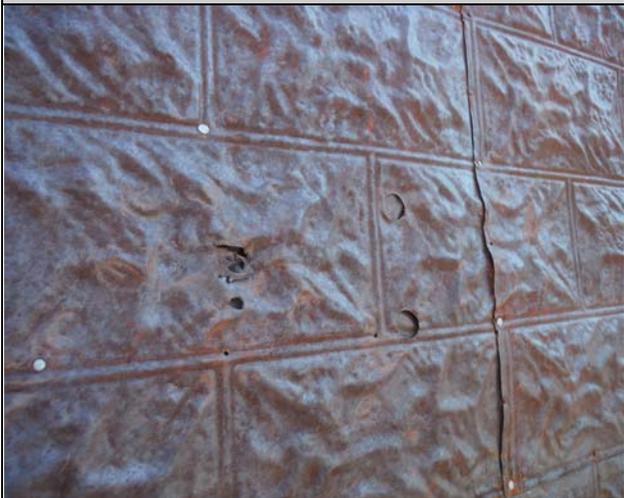
| PHOTO – WORK ITEM | DESCRIPTION | ACTION |
|---|---|---|
| | <p>9/9/17 – Photo 16</p> <p>West Elevation Details. Holes have been patched with rusted metal.</p> | <p>Note</p> |

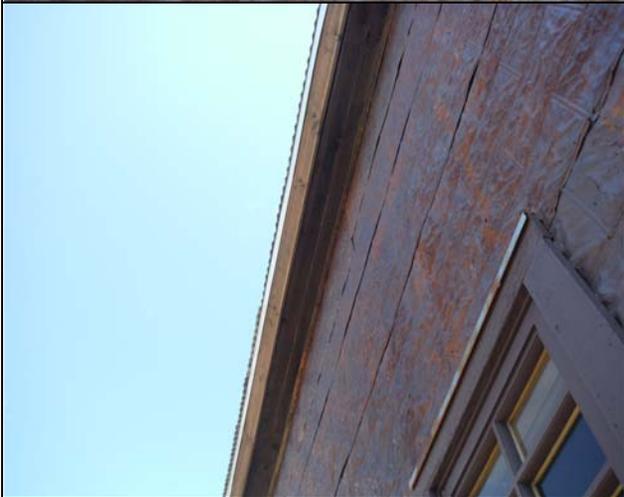
| PHOTO – WORK ITEM | DESCRIPTION | ACTION |
|---|---|---|
| | <p>9/9/17 – Photo 17</p> <p>West Elevation Detail Looking Up. Metal panels have been realigned.</p> | <p>Note</p> |

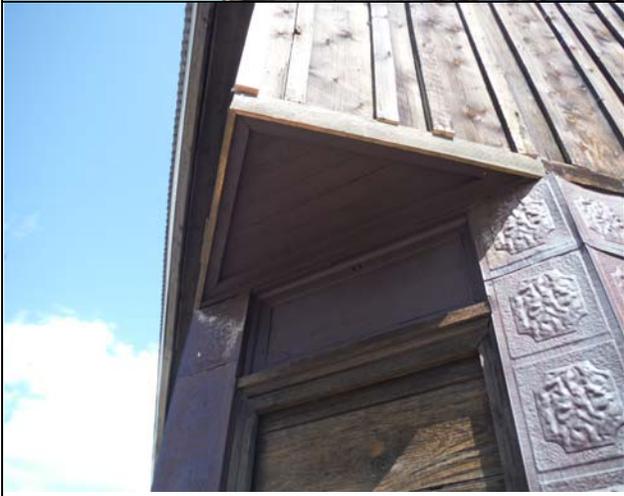
| PHOTO – WORK ITEM | DESCRIPTION | ACTION |
|---|---|---|
| | <p>9/9/17 – Photo 18</p> <p>Southwest Corner Soffit Detail. Wood soffit has been painted. Evidence of paint existed in this location. Replica corner trim and edge trim has been installed.</p> | <p>Note</p> |

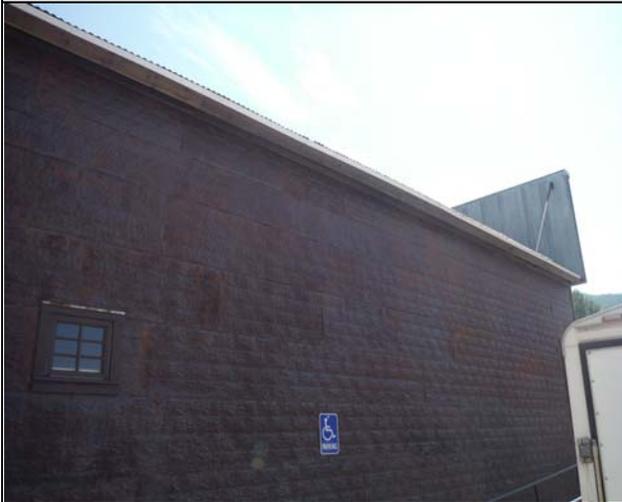
| PHOTO – WORK ITEM | DESCRIPTION | ACTION |
|---|--|---|
| | <p>9/9/17 – Photo 19</p> <p>West Elevation Looking South Metal wall panels have been realigned. West side window has been installed and painted.</p> <p>Remnants of the cliff swallow nests have been removed.</p> | <p>Note</p> |

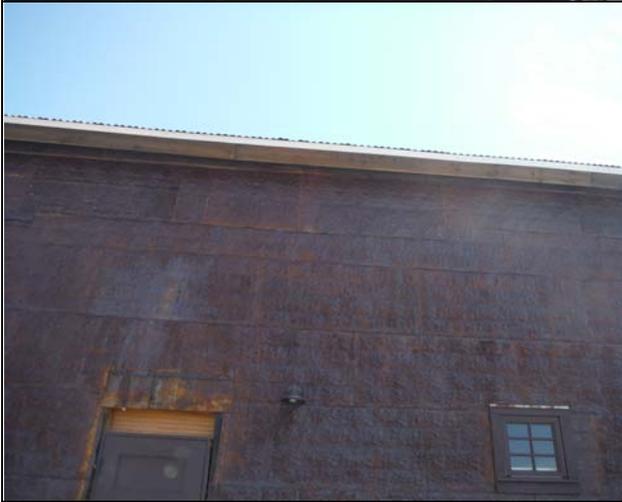
| PHOTO – WORK ITEM | DESCRIPTION | ACTION |
|---|--|---|
| | <p>9/9/17 – Photo 20</p> <p>West Elevation. Top row of metal panels has been realigned. Wood blocking from the previous overhead electrical service has been removed.</p> | <p>Note</p> |

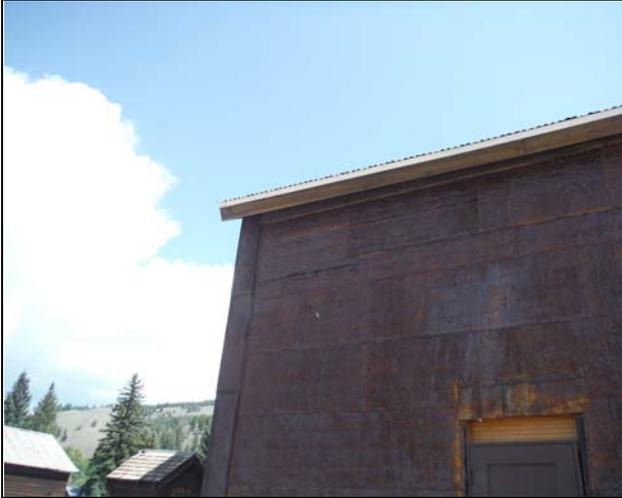
| PHOTO – WORK ITEM | DESCRIPTION | ACTION |
|---|--|---|
| | <p>9/9/17 – Photo 21</p> <p>West Elevation, North Corner Detail. Metal corner trim has been relocated. Metal panels have been realigned. Awaiting transom window above the side exit door.</p> | <p>Note</p> |

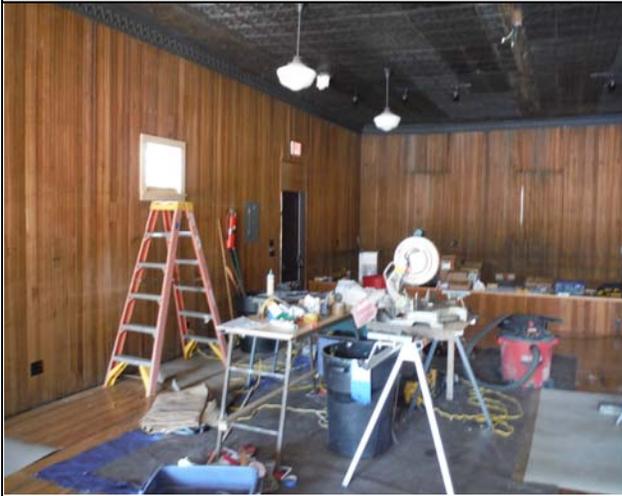
| PHOTO – WORK ITEM | DESCRIPTION | ACTION |
|---|--|---|
| | <p>9/9/17 – Photo 22</p> <p>North Interior View.</p> <p>Work on the hardwood floor and stage is complete. Awaiting wall base and installation of the metal ceiling tiles.</p> | <p>Note</p> |

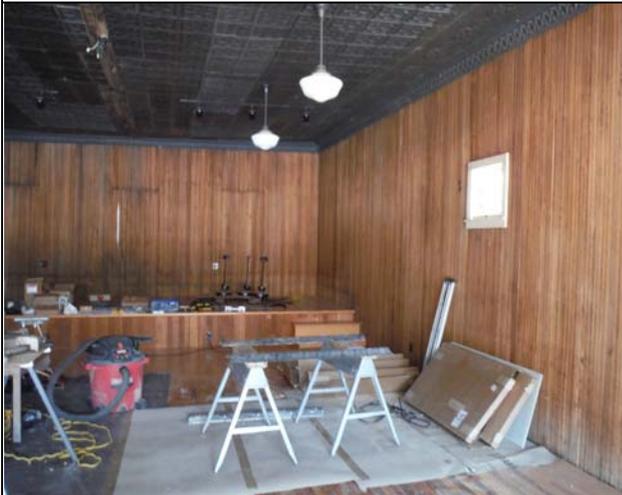
| PHOTO – WORK ITEM | DESCRIPTION | ACTION |
|---|--|---|
| | <p>9/9/17 – Photo 23</p> <p>North Interior View.</p> <p>Awaiting installation of the stage step handrail, stove floor and wall protection, and cleaning of the bead board wall panels.</p> | <p>Note</p> |

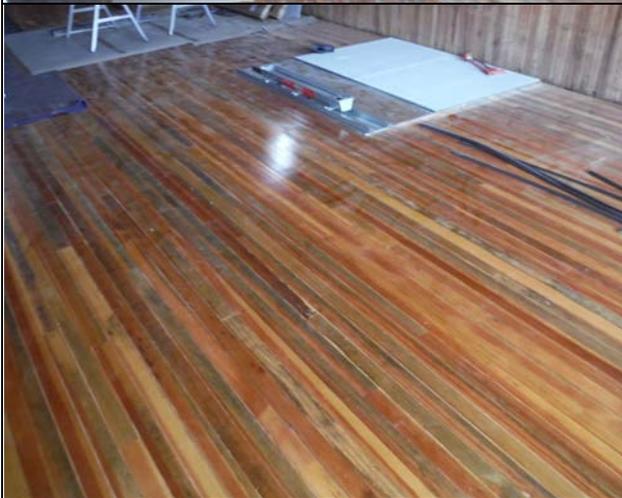
| PHOTO – WORK ITEM | DESCRIPTION | ACTION |
|---|--|---|
| | <p>9/9/17 – Photo 24</p> <p>Photo of reinstalled and refinished hardwood floor.</p> <p>Stove protection is seen in the top of the photo.</p> | <p>Note</p> |

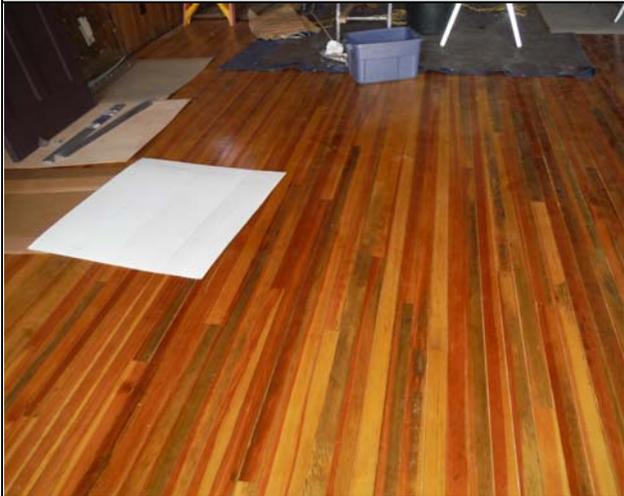
| PHOTO – WORK ITEM | DESCRIPTION | ACTION |
|---|---|---|
| | <p>9/9/17 – Photo 25</p> <p>Photo of reinstalled and refinished hardwood floor.</p> <p>Historic wood flooring has been installed toward the front of the building.</p> | <p>Note</p> |

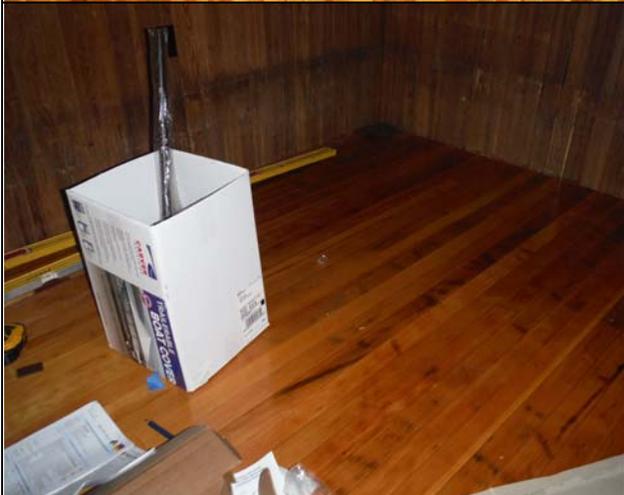
| PHOTO – WORK ITEM | DESCRIPTION | ACTION |
|---|---|---|
| | <p>9/9/17 – Photo 26</p> <p>Photo of the refinished stage floor. Bead board wall will be cleaned.</p> | <p>Note</p> |

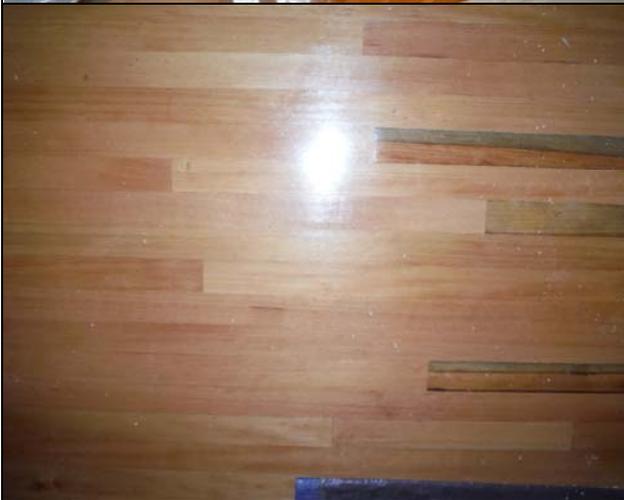
| PHOTO – WORK ITEM | DESCRIPTION | ACTION |
|---|---|---|
| | <p>9/9/17 – Photo 27</p> <p>Example photo of the intersection of historic wood floor (right) and the repurposed wood floor (left.) Over 95% of the wood floor was removed and reinstalled. The existing, non-historic wood floor was removed, milled to match and reused.</p> | <p>Note</p> |

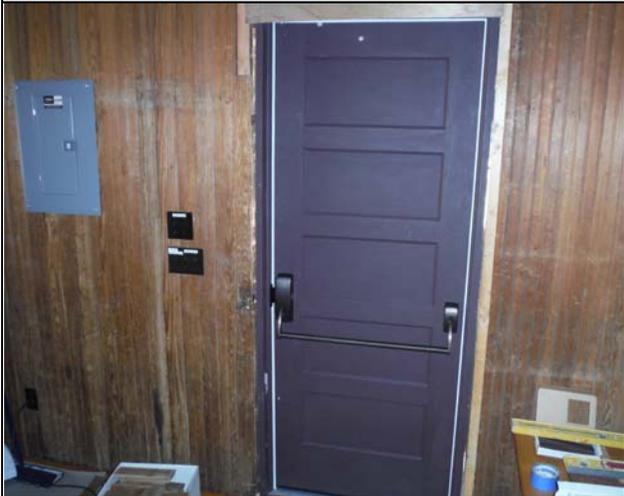
| PHOTO – WORK ITEM | DESCRIPTION | ACTION |
|---|---|---|
| | <p>9/9/17 – Photo 28</p> <p>Recreated 5-panel side door. The door swing has been reversed to allow for emergency egress and panic hardware has been installed. The paint color matches the previous trim color.</p> | <p>Note</p> |

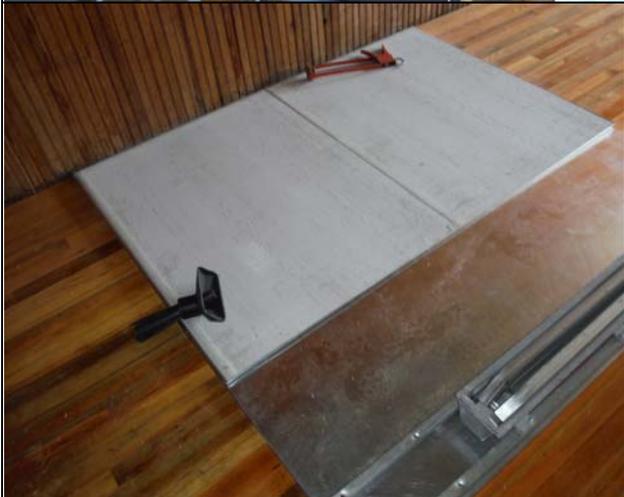
| PHOTO – WORK ITEM | DESCRIPTION | ACTION |
|---|---|---|
| | <p>9/9/17 – Photo 29</p> <p>Galvanized metal stove base and wall protection. The building is exclusively heated with a wood fired stove.</p> | <p>Note</p> |

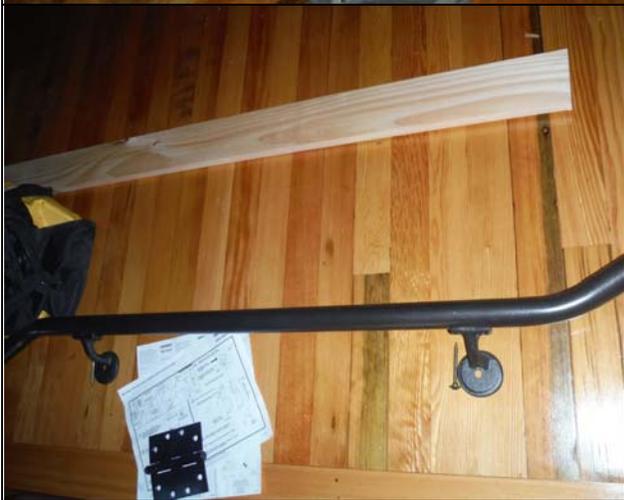
| PHOTO – WORK ITEM | DESCRIPTION | ACTION |
|---|---|---|
| | <p>9/9/17 – Photo 30</p> <p>Detail of the handrail for the stage steps. Addition of the handrail is to assist the aging user group of the building.</p> | <p>Note</p> |

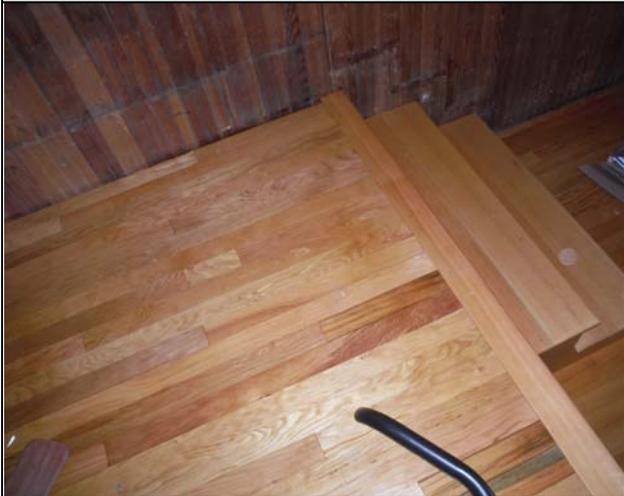
| PHOTO – WORK ITEM | DESCRIPTION | ACTION |
|---|---|---|
| | <p>9/9/17 – Photo 31</p> <p>Detail of refinished stage and steps. The bead board wall cover will be cleaned.</p> | <p>Note</p> |

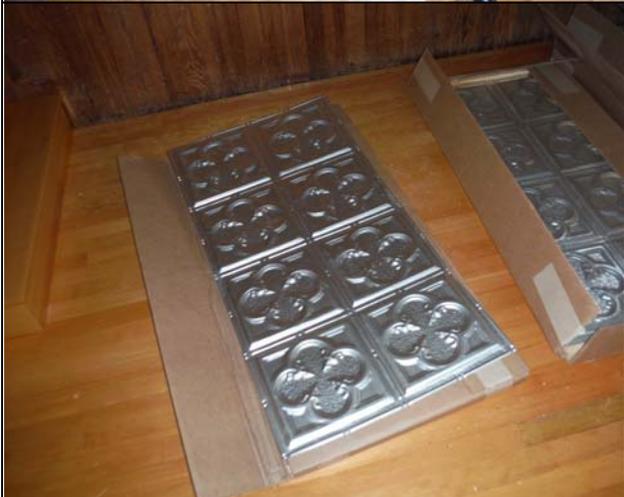
| PHOTO – WORK ITEM | DESCRIPTION | ACTION |
|---|---|---|
| | <p>9/9/17 – Photo 32</p> <p>Replica metal ceiling tiles have been delivered.</p> | <p>Note</p> |

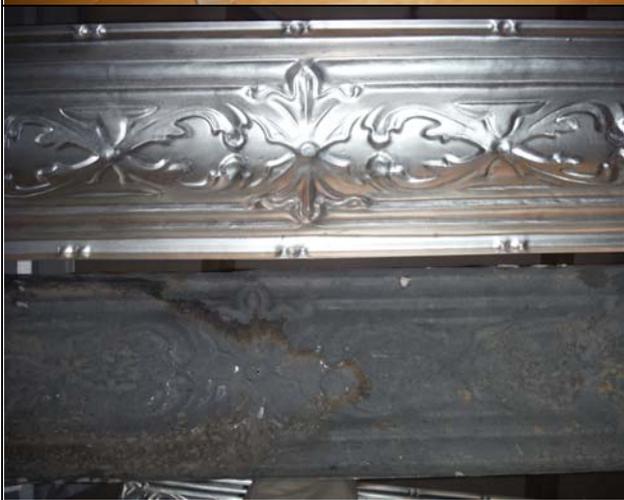
| PHOTO – WORK ITEM | DESCRIPTION | ACTION |
|---|---|---|
| | <p>9/9/17 – Photo 33</p> <p>Example photo of recreated metal ceiling molding and the existing ceiling molding. The metal ceiling has developed a patina due to the smoke from the wood-fired stove.</p> | <p>Note</p> |
