ARCHITECT'S FIELD REPORT

03

PROJECT	Ohio City Town Hall Interior and Exterior Rehabilitation, Phase II SHF Project # 2017-01-021	DATE	9/22/2017
----------------	---	-------------	-----------

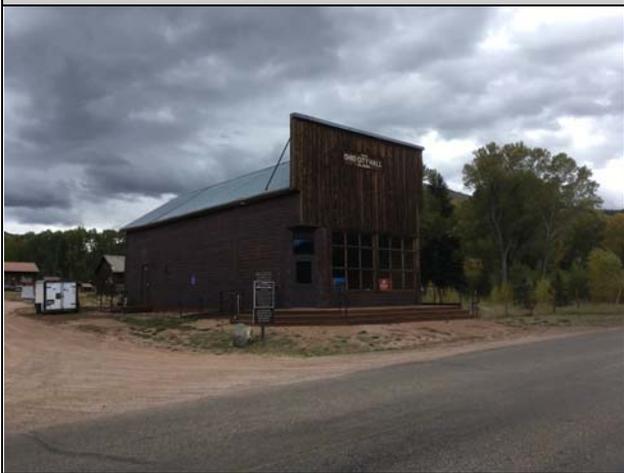
<p>9/22/17 – Photo 1</p> <p>Southwest Elevation showing the recreated entry door.</p>	<p>Note</p>

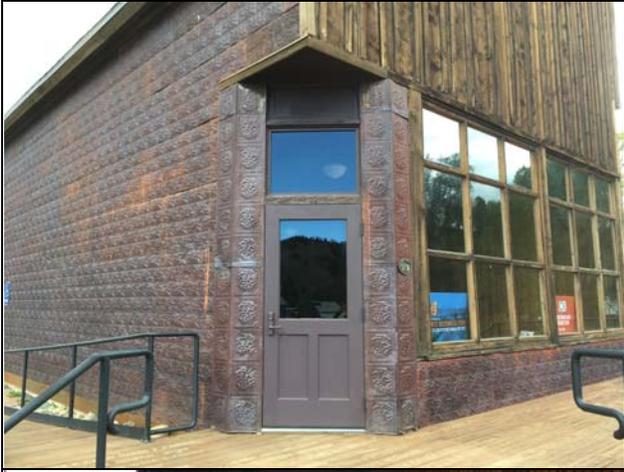
<p>9/22/17 – Photo 2</p> <p>Recreated main entry door and transom window.</p> <p>The door swings to the exterior to comply with egress codes.</p>	<p>Note</p>

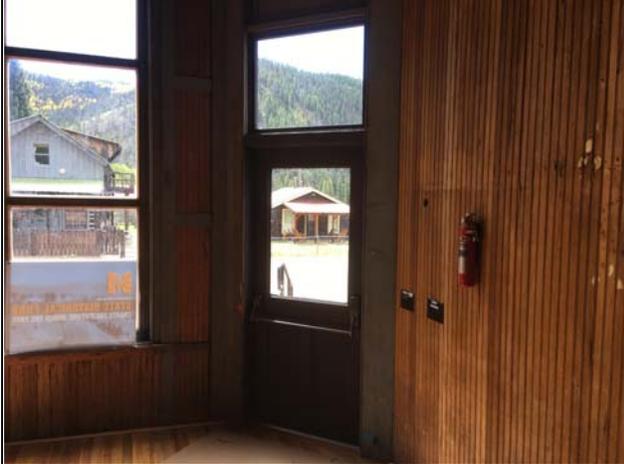
<p>9/22/17 – Photo 3</p> <p>Interior view of main entry door. Panic hardware and interior trim have been installed.</p>	<p>Note</p>

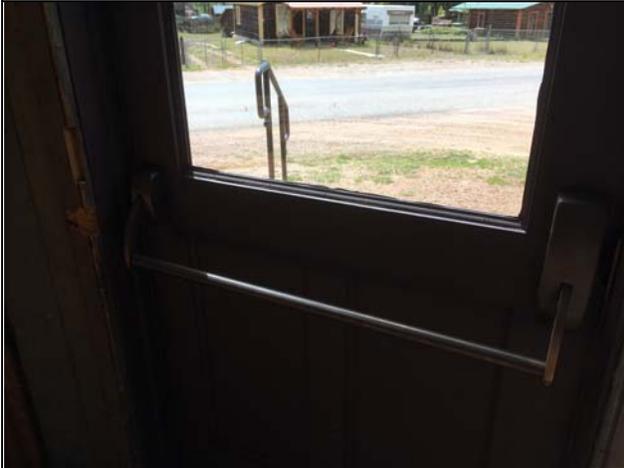
<p>9/22/17 – Photo 4</p> <p>Main entry door – detail of panic hardware.</p>	<p>Note</p>

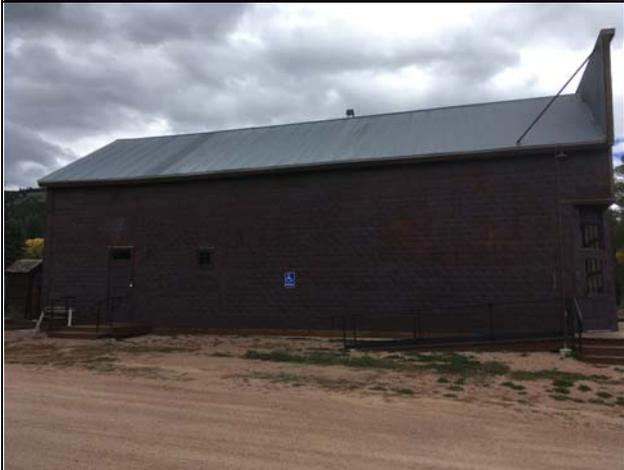
<p>9/22/17 – Photo 5</p> <p>West Elevation. Completed work on this elevation.</p>	<p>Note</p>

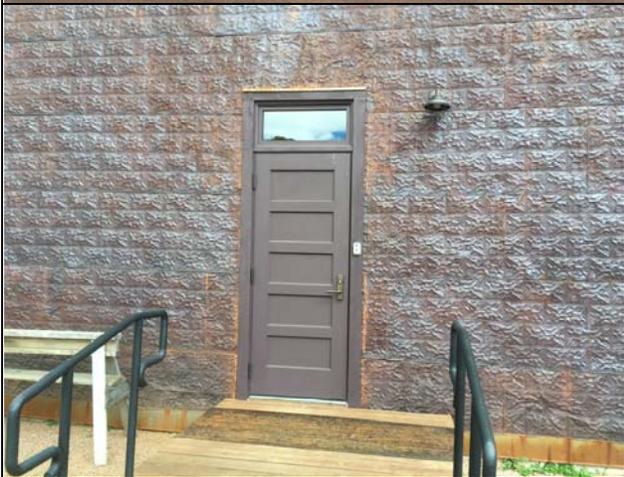
<p>9/22/17 – Photo 6</p> <p>Side entry door transom window has been installed. Flashing is installed at the window head.</p> <p>Door hardware is functional.</p>	<p>Note</p>

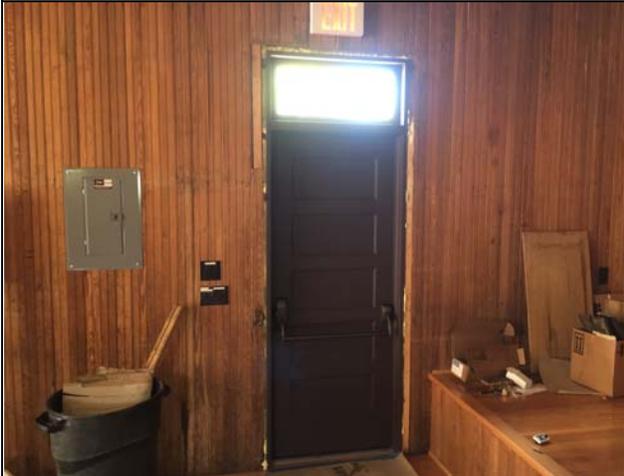
<p>9/22/17 – Photo 7</p> <p>Interior detail of the side entry door. Panic hardware is operational. Awaiting interior door trim.</p>	<p>Note</p>

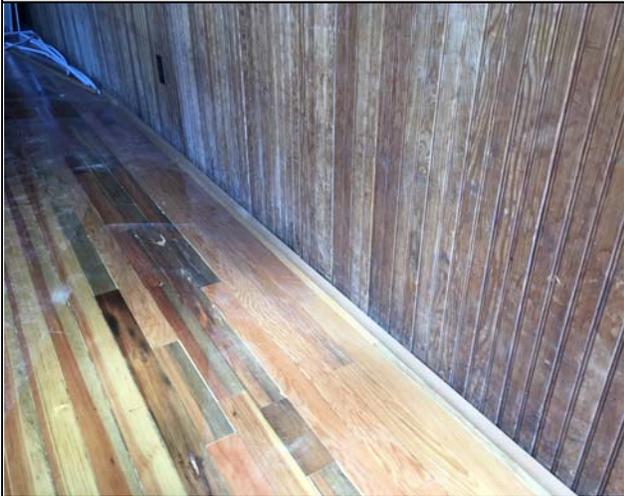
<p>9/22/17 – Photo 10</p> <p>Wood base trim has been installed.</p>	<p>Note</p>

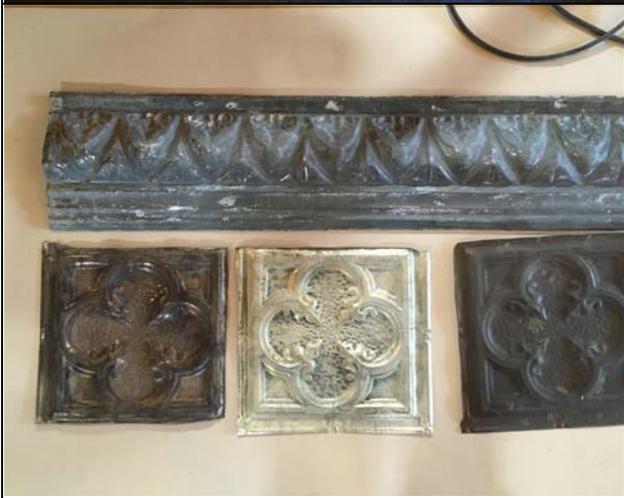
<p>9/22/17 – Photo 12</p> <p>Metal Ceiling Tile Mock Up</p> <p>Original trim above with a smoky patina. Examples of three new ceiling tiles with varying degrees of chemical patina.</p> <p>Product Name: Sculpt Nouveau “Slate Black”</p>	<p>Note</p>

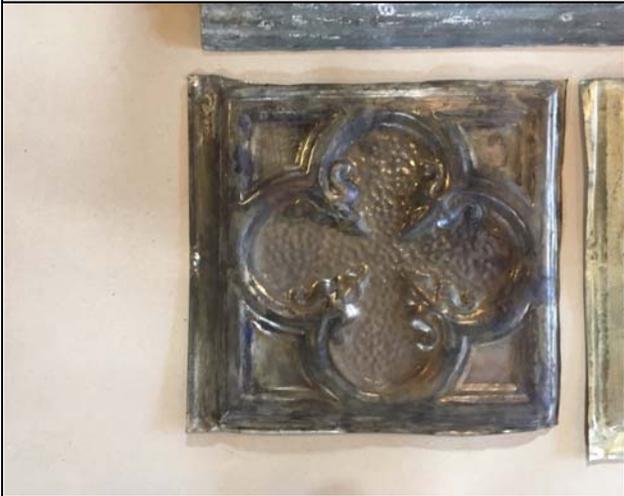
<p>9/22/17 – Photo 13</p> <p>Metal Ceiling Tile Mock Up</p> <p>Chemical patina to match the majority of the ceiling tiles.</p>	<p>Note</p>

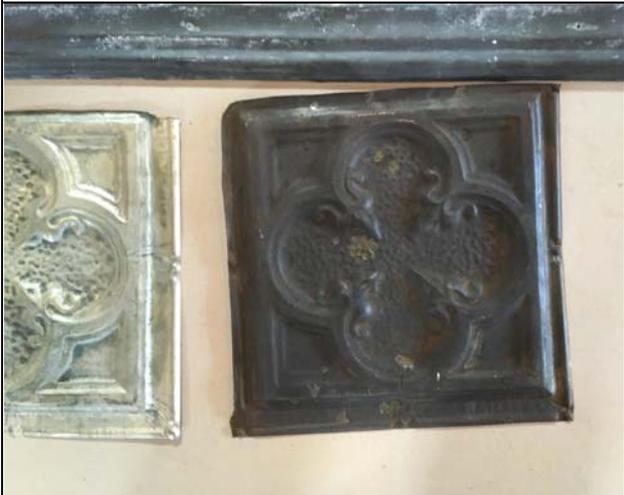
<p>9/22/17 – Photo 14</p> <p>Metal Ceiling Tile Mock Up</p> <p>Chemical Patina to match the ceiling tiles surround the wood stove flue that are the darkest patina.</p>	<p>Note</p>

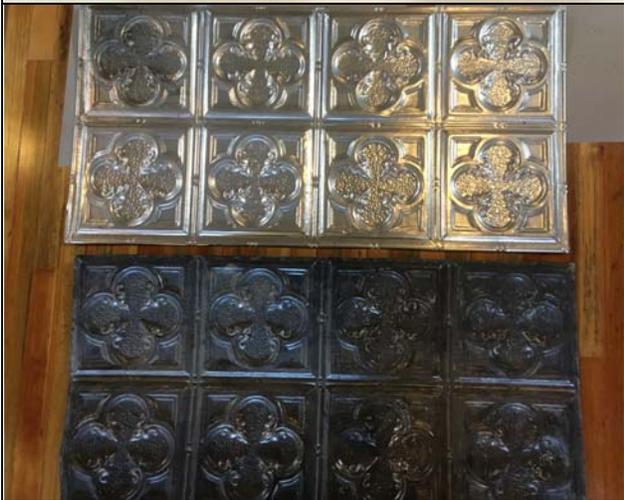
<p>9/22/17 – Photo 15</p> <p>Metal Ceiling Tile Mock Up</p> <p>Chemical patina before and after photo.</p>	<p>Note</p>

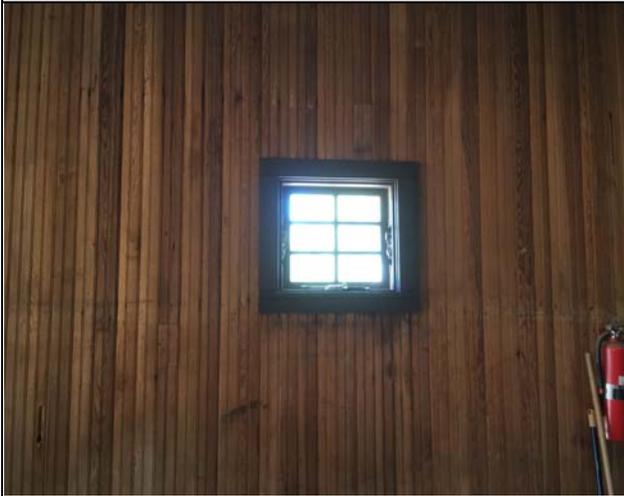
<p>9/22/17 – Photo 16</p> <p>West side window interior. The interior windows and window trims have been painted.</p>	<p>Note</p>

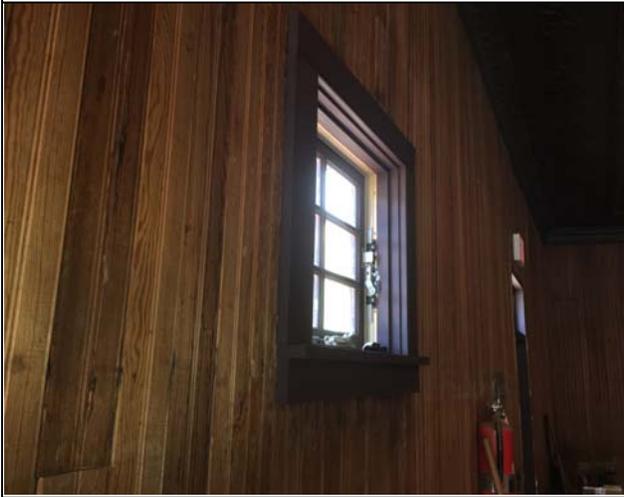
<p>9/22/17 – Photo 17</p> <p>West side window interior.</p> <p>The window crank cover has not yet been installed.</p>	<p>Note</p>
