ARCHITECT'S FIELD REPORT

05

PROJECT	Ohio City Town Hall Interior and Exterior Rehabilitation, Phase II SHF Project # 2017-01-021	DATE	5/9/18
----------------	---	-------------	--------

WORK OBSERVED	
Storefront Window Rehabilitation; Shear Reinforcing	
TRADES PRESENT	
None

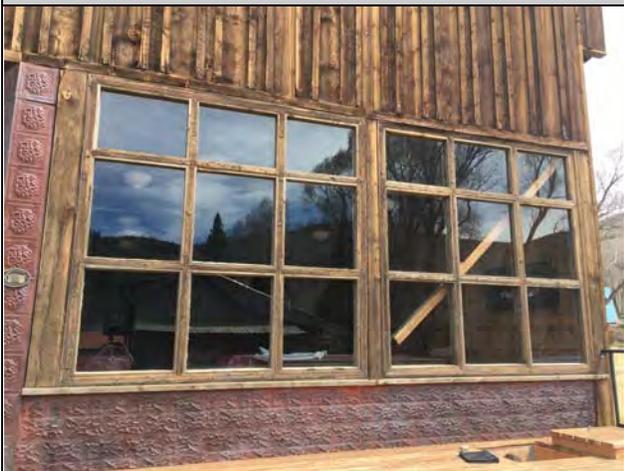
<p>5/9/18 – Photo 1</p> <p>The completed storefront rehabilitation.</p>	<p>Note</p>

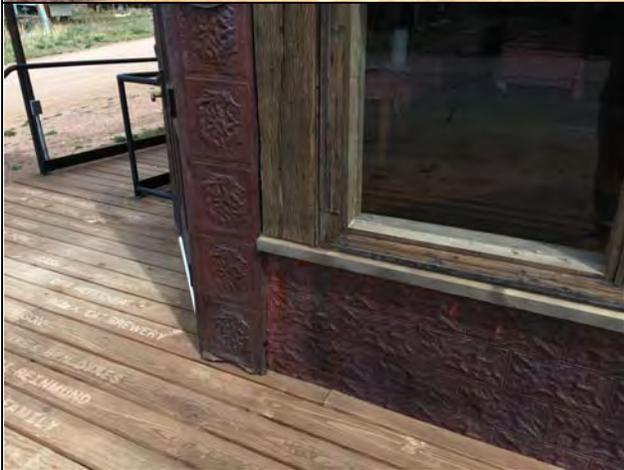
<p>5/9/18 – Photo 2</p> <p>Detail of the southwest corner. The sill plate has been replaced with replica material.</p>	<p>Note</p>

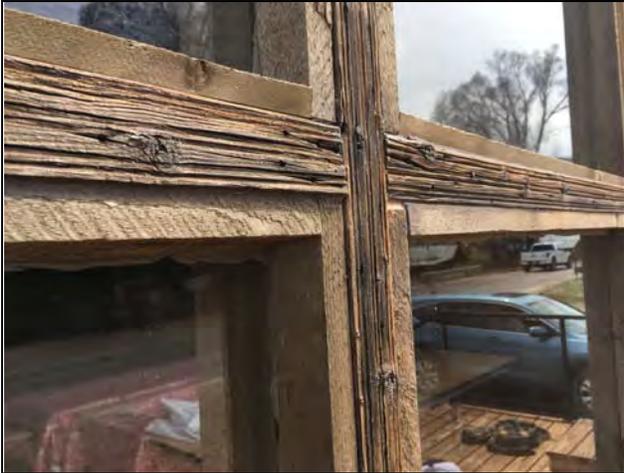
<p>5/9/18 – Photo 3</p> <p>Detail of the mid-span trim. Existing trim has been reinstalled; rough-sawn trim has been used for the exterior stops.</p>	<p>Note</p>

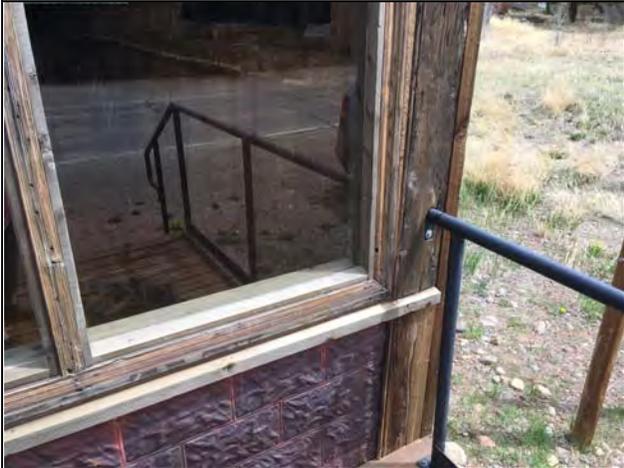
<p>5/9/18 – Photo 4</p> <p>Detail of the southeast corner. Replica sill trim has been installed.</p>	<p>Note</p>

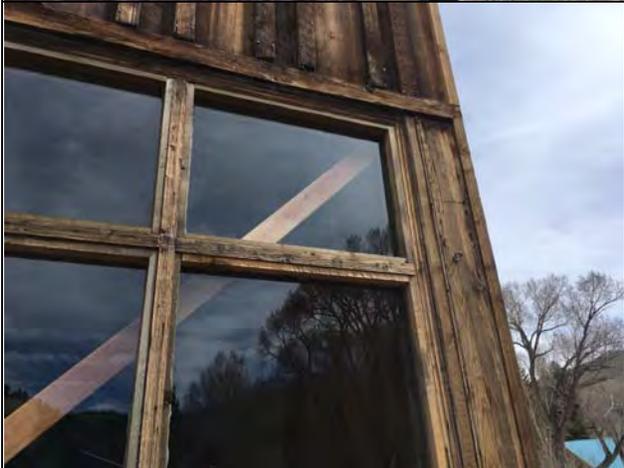
<p>5/9/18 – Photo 5</p> <p>Detail of the southeast top corner. Historic wood trim has been reinstalled.</p>	<p>Note</p>

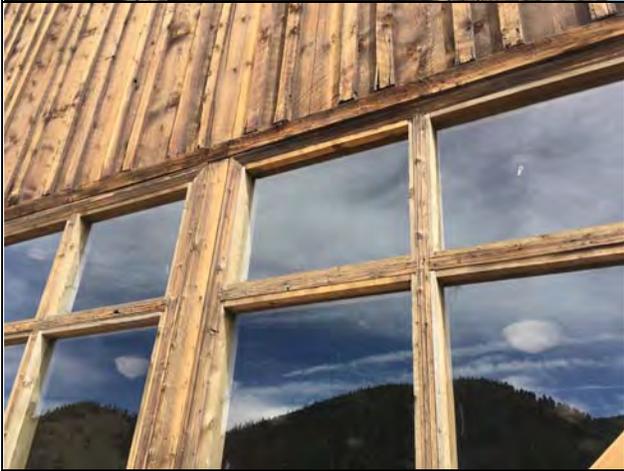
<p>5/9/18 – Photo 6</p> <p>Detail of the mid-post of the storefront window.</p>	<p>Note</p>

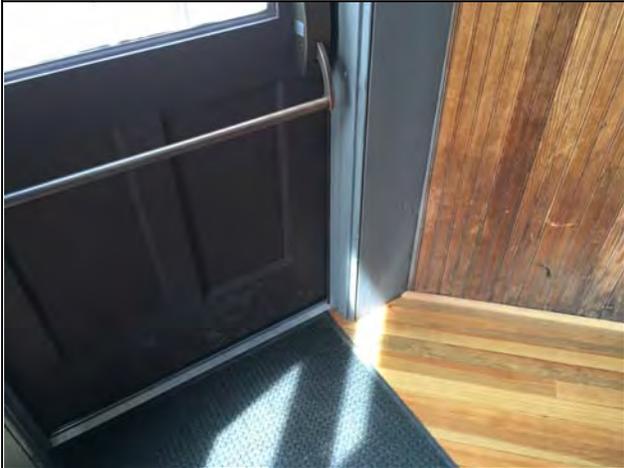
<p>5/9/18 – Photo 7</p> <p>Detail of the interior trim around the entry door. Trim has been painted grey.</p>	<p>Note</p>

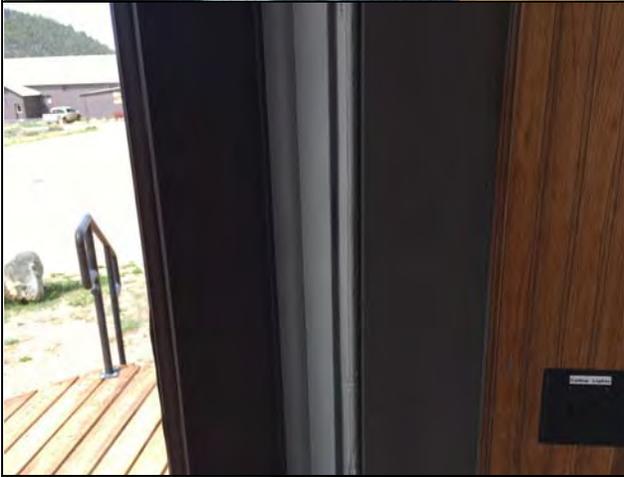
<p>5/9/18 – Photo 8</p> <p>Detail of the historic interior trim around the entry door.</p>	<p>Note</p>

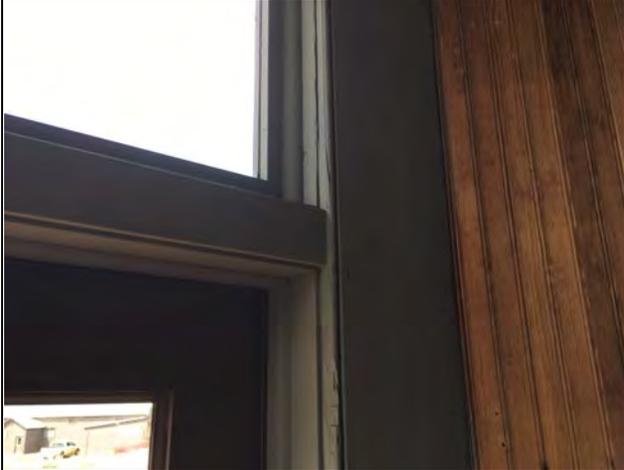
<p>5/9/18 – Photo 9</p> <p>Detail of the interior trim at the transom window. Trim has been painted grey.</p>	<p>Note</p>

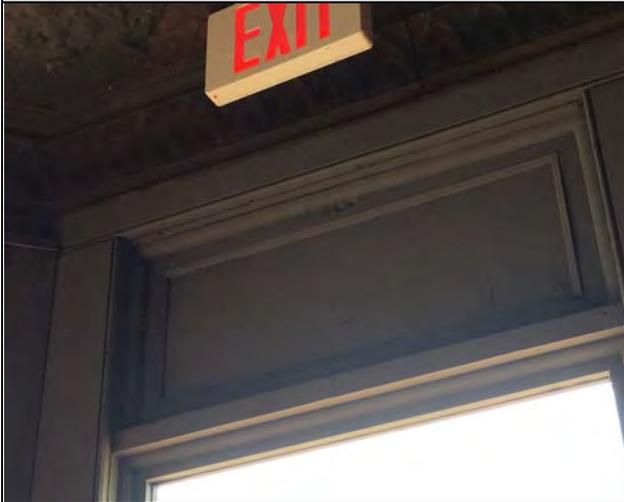
<p>5/9/18 – Photo 10</p> <p>Detail of the upper transom panel above the entry door. Trim has been painted grey.</p>	<p>Note</p>

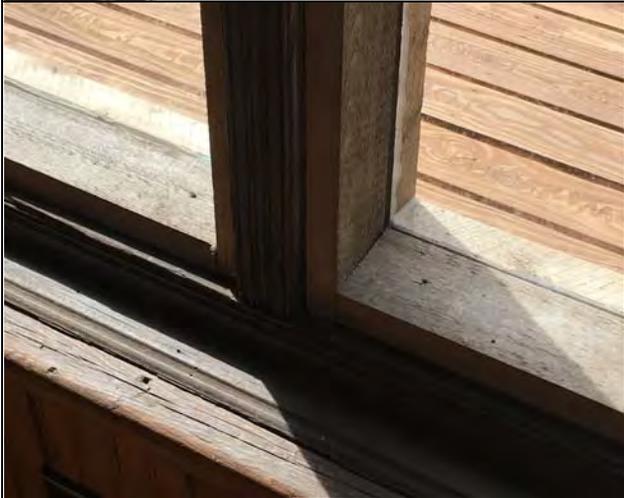
<p>5/9/18 – Photo 11</p> <p>Interior detail of the sill and window stops.</p>	<p>Note</p>

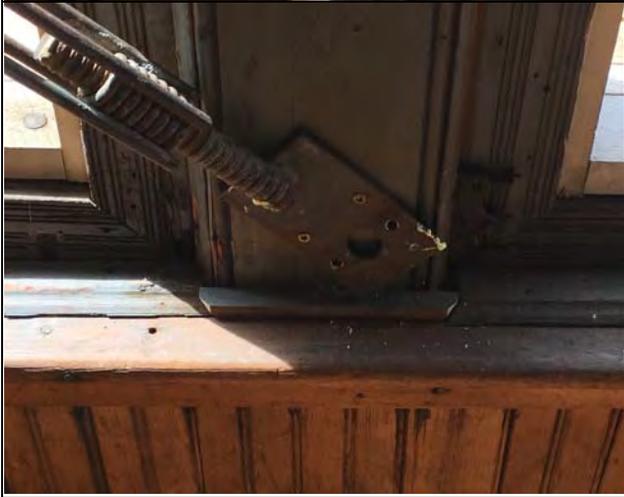
<p>5/9/18 – Photo 12</p> <p>Detail of the interior mid-post. Note the temporary bracing is still in place.</p> <p>The bracing is helping to prevent racking of the storefront window but does not provide shear resistance for the south wall.</p>	<p>Note</p>

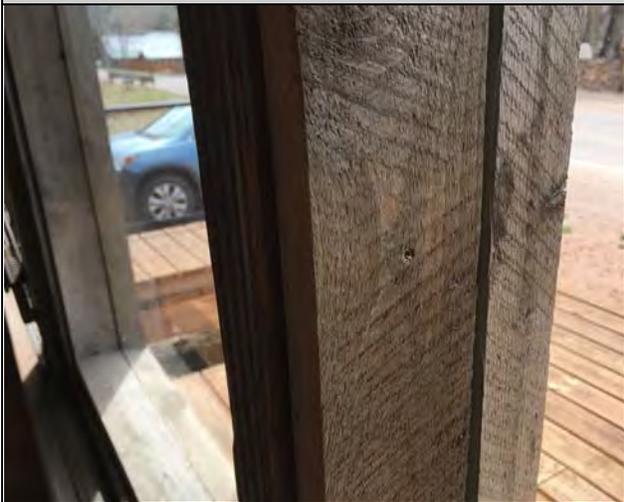
<p>5/9/18 – Photo 13</p> <p>Detail of the interior window stop. Note the exposed screw head to allow the stop to be removed.</p>	<p>Note</p>

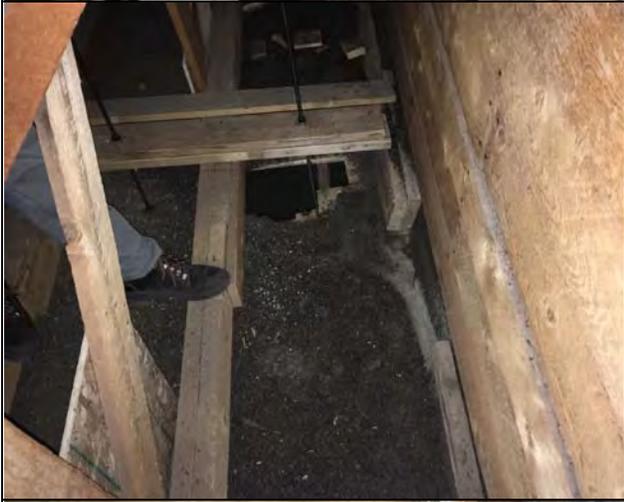
<p>5/9/18 – Photo 14</p> <p>Photo in the attic, south end, last truss bay. The area was examined to see if a shear wall could be constructed in the attic space.</p> <p>Note the large quantity of rodent feces. This condition will need to be addressed prior to any work performed in the attic.</p>	<p>Note</p>

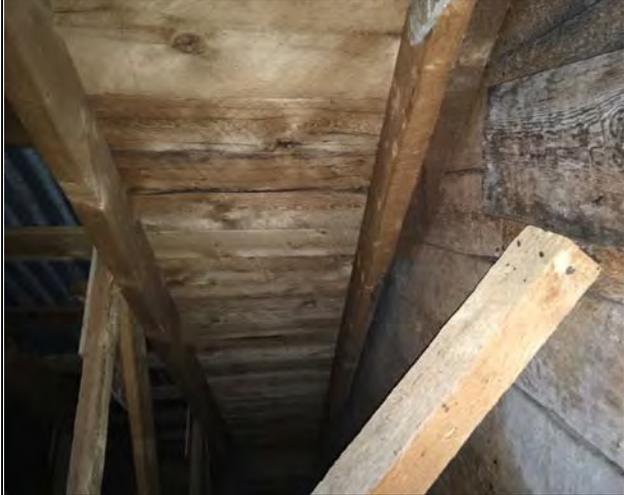
<p>5/9/18 – Photo 15</p> <p>Photo of the attic, south end, last truss bay. The wood boards are the roof sheathing; the wood wall to the right is the interior side of the parapet wall.</p>	<p>Note</p>
