Gunnison County, CO

COURTHOUSE NEEDS & SYSTEMS ASSESSMENTS,
SPACE PLANNING AND BASIC BUILDING PROGRAMMING

ROTH
SHEPPARD
MARCH 26, 2013

HUMPHRIES
POLI
ARCHITECTS

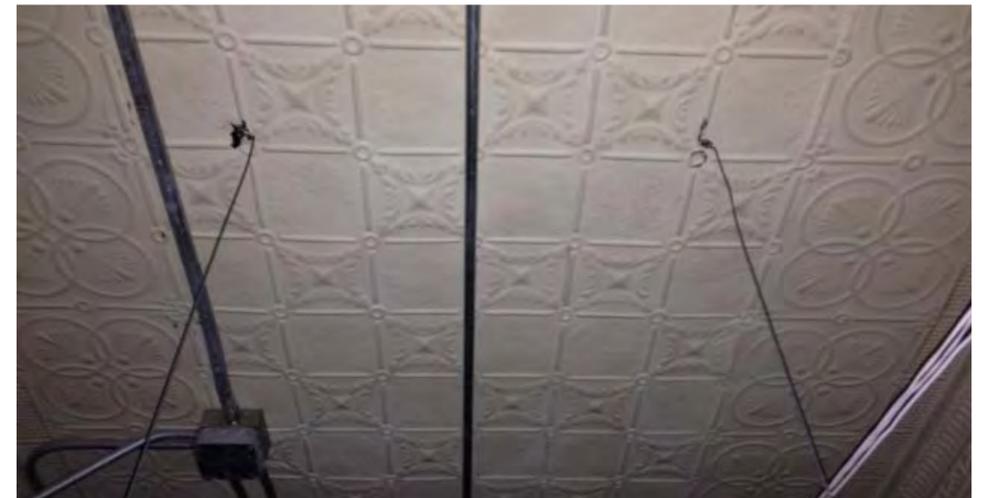
Pressed metal ceiling above corridor dropped ceiling

- Based on these conditions we recommend that future preservation efforts for the courthouse focus on interpretative displays about the history of the building, which could be centered on the many historic photographs of the building that exist as well as the pressed metal ceilings. Though not as impactful, it is possible that original wood floors exist beneath the carpet areas in the 1881 portion of the building. Revealing these floors in concert with the metal ceilings in selected rooms could evoke the history of the space. Although it would be possible to reveal or recreate some of the other character defining features of the building these endeavors would be costly and in the case of the brick may not be assured of success given the unknown condition.

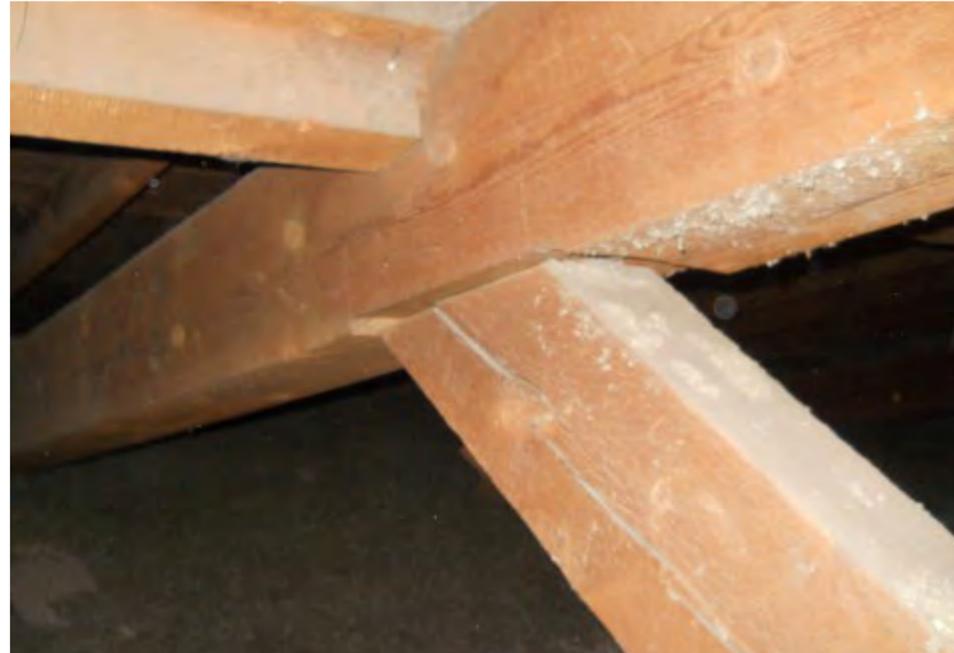
Photo 1, Gap at Truss Joint, Original 1881 Courthouse

- Several items of structural concern were noted.
 1. At least one wood-to-wood joint in the heavy timber roof trusses in the original 1881 courthouse had a significant gap which results in reduced truss strength. See Photos 1 and 2.

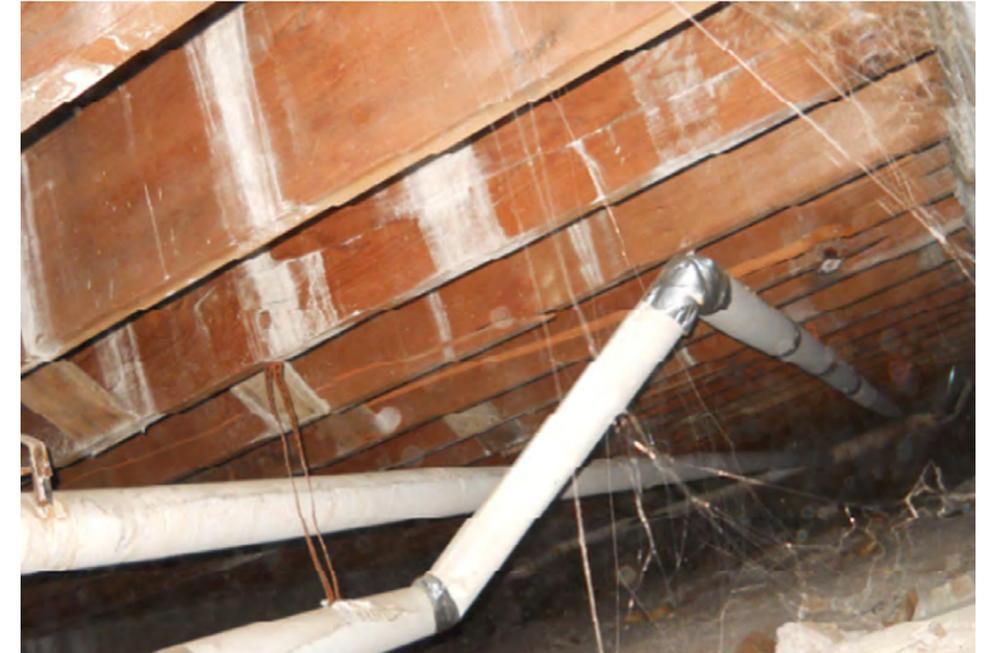
Photo 3, cracked and broken floor joists, Original Jail

2. Several cracked and broken wood floor joists were observed in the crawl space under the original jail. See Photo 3.
- Proposed changes in space use should not require a floor live load capacity greater than required for the historically use, or a structural investigation and calculations should be performed to confirm the floor live load capacity.

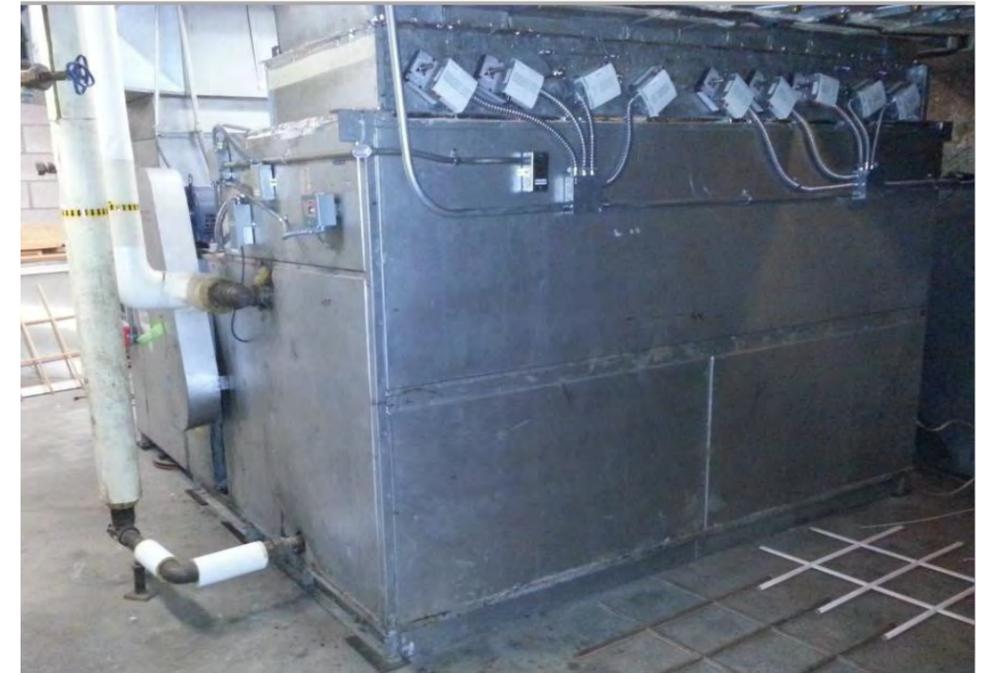
Converted Multizone Ahu-1

- The air handling units located in the attic are all very difficult to access and the clearance for servicing is poor to nonexistent. All of this equipment is beyond its mean service life of 20 years and should be replaced.

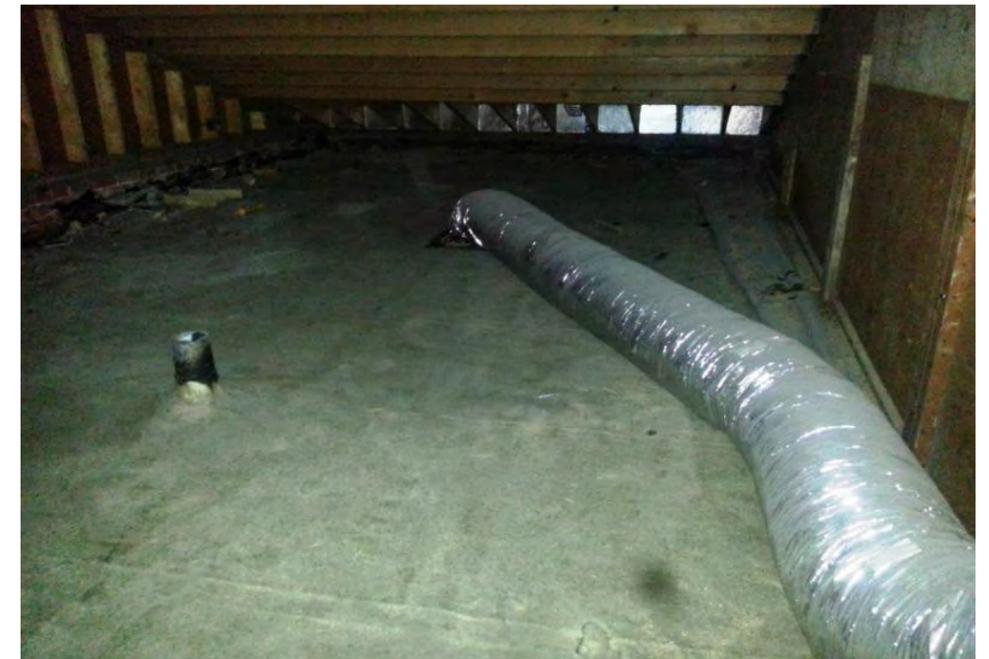
- The waste piping is a combination of PVC and cast iron, with several leaks. Some of the waste piping in the crawl space is heat taped to prevent the piping from freezing. Where some of the past remodel areas were completed a gable roof was added, but when the roofs were added the existing vent piping was not extended through the attics and through the new roofs. This does not comply with current plumbing codes.

- The Court Room evaporative coolers are located in the same attics as the plumbing vent terminations. Since the air for the evaporative coolers is drawn from the attic space it will be mixed with the air from the plumbing vents. In general, the plumbing system is beyond its mean service life and will need to be replaced.

Existing Plumbing Vent into Attic

- The plumbing system is antiquated and needs to be replaced with a new, code-compliant design using updated piping and fixtures.
- The existing fire sprinkler system will need to be upgraded as required for compliance with the local authority's requirements.

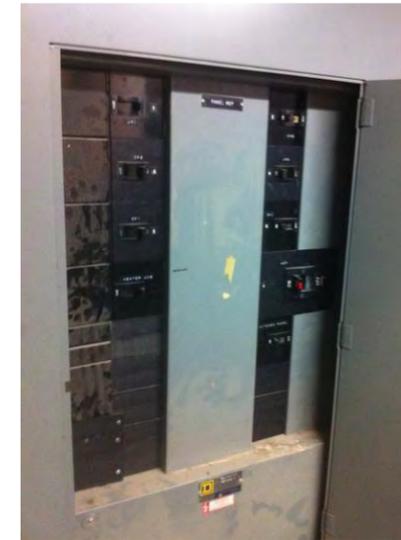
Main Distribution Panel

- The MDP was sized for the existing building square footage and occupancy type. Despite its age, it appears to be in good condition and suitable for reuse.

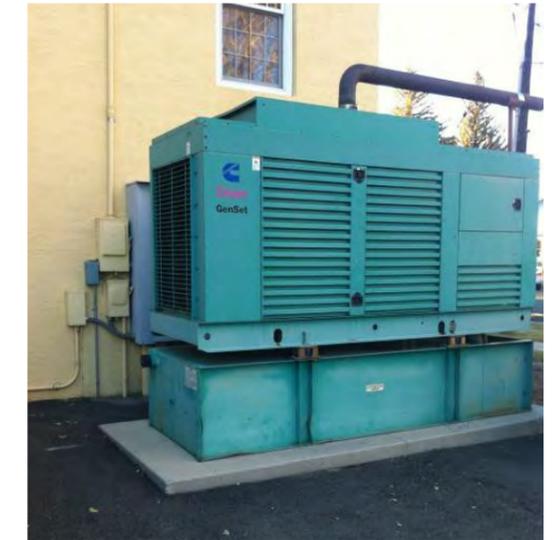
- A Cummins diesel generator with an integral belly tank and exterior automatic transfer switch (ATS) were added prior to the year 2000. This equipment was designed to back up the entire building. It is recommended that this equipment be reused for the renovated building.

Generator

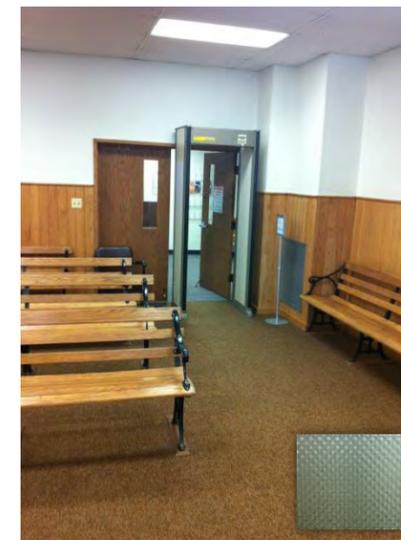
- The interior lighting has been replaced with T8 lamps.
- Most of the recessed luminaires have an acrylic prismatic lens and could be reused.
- It is anticipated that most renovated spaces would utilize more modern indirect/direct lighting.
- The luminaires in the old jail would be removed and replaced.
- The historic metal ceiling in the old Sheriff's office has pendant luminaires, which would likely be replaced with indirect/direct or decorative pendants.

2x4 Fixture with Acrylic Prismatic Lens

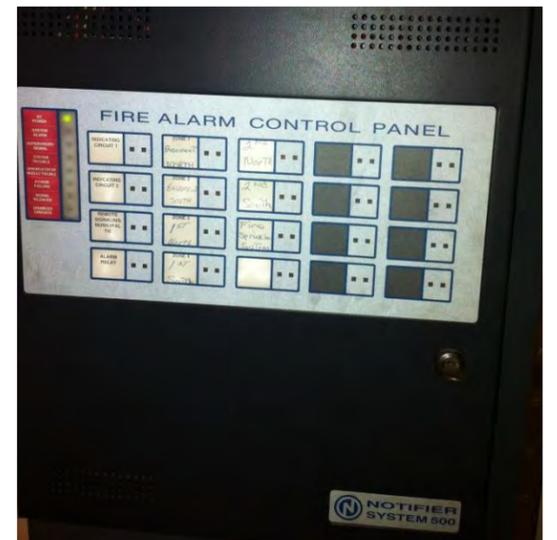
- The existing fire alarm system was manufactured around 1995, and most of the detectors are likely to be out of calibration. Re-calibration can be difficult to achieve, and it is generally more cost effective to replace detectors from this timeframe rather than re-calibrate them.
- Existing notification horns and strobes would likely need to be relocated to accommodate the future renovation and current ADA requirements.
- **We recommend that the existing Fire Alarm system be removed and a new Fire Alarm Control Panel, device and wiring be installed**

Fire Alarm Control Panel

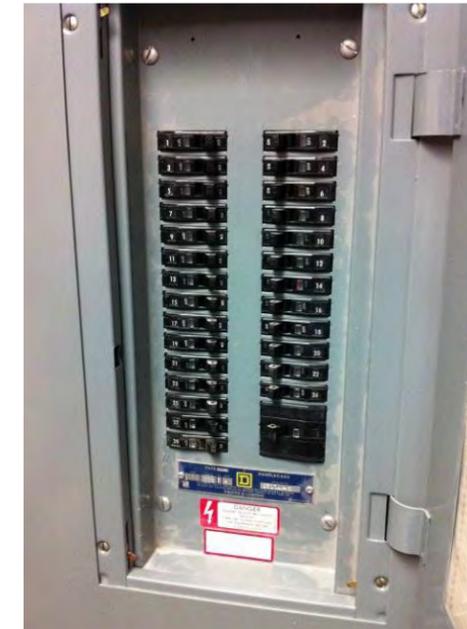
- There are several branch circuit panels throughout the building. Most of these panels appear to be in good condition and meet current codes for wire bending space. Therefore, they could be reused.
- Most of the panels do not have space for additional circuits. As a result, it is anticipated that 3 or 4 new panels would be added to supplement the existing panels in order to accommodate the future renovation.
- The new panels would be located as dictated by future loads and space configurations.

Typical Electrical Panel

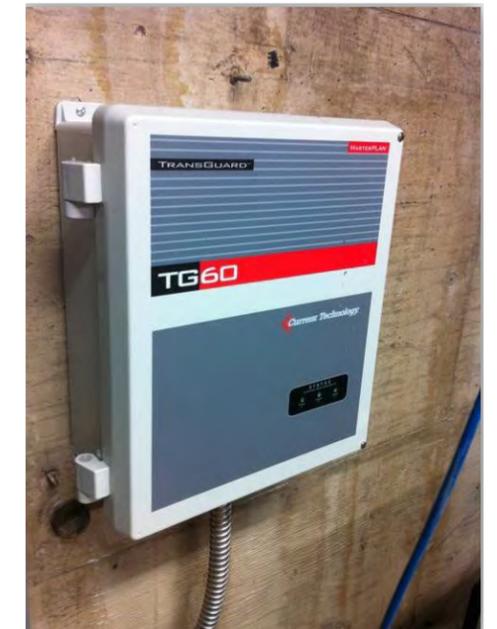
Surge Protective Device

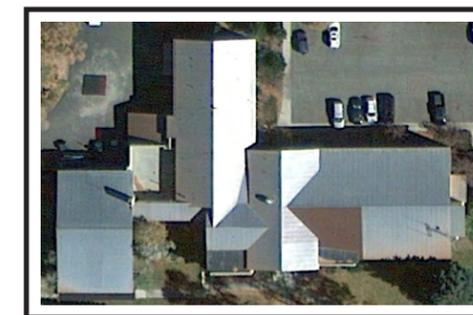
Existing Roof

- The existing roof is a continuing maintenance problem, it is in need of complete replacement.

1. Roof replacement is the single most priority. The existing roof is at the end of its useful life and is a continuing maintenance issue. If nothing else is done to the existing building, the roof must be replaced.

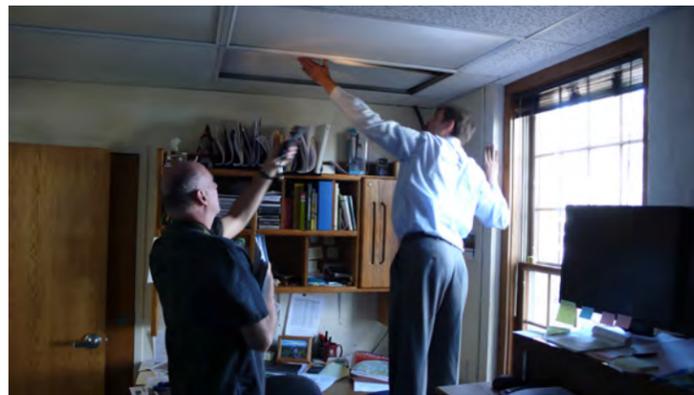
Replace drop ceilings throughout the building

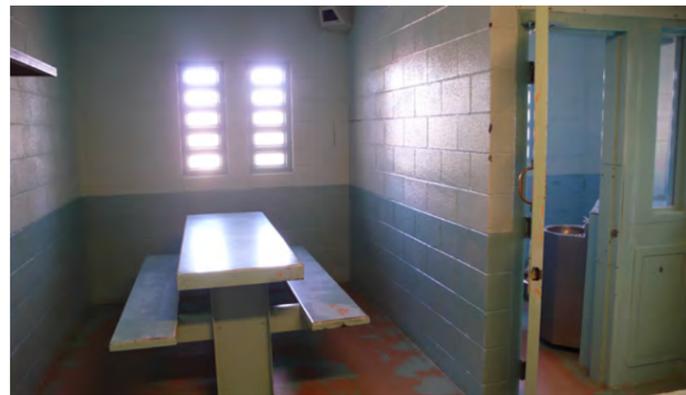
Re-purpose former jail space to potentially convert "hard" cells upstairs for secure records storage; and conversion of former jail spaces downstairs for office space, and staff break room

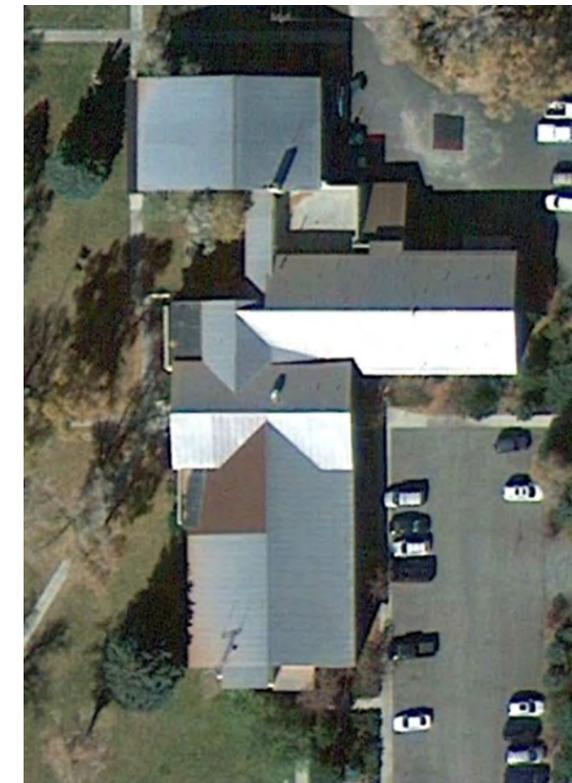
Replace roof

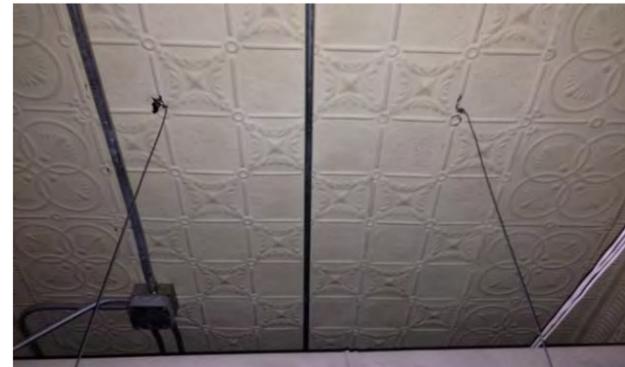
Pressed metal ceiling above corridor dropped ceiling

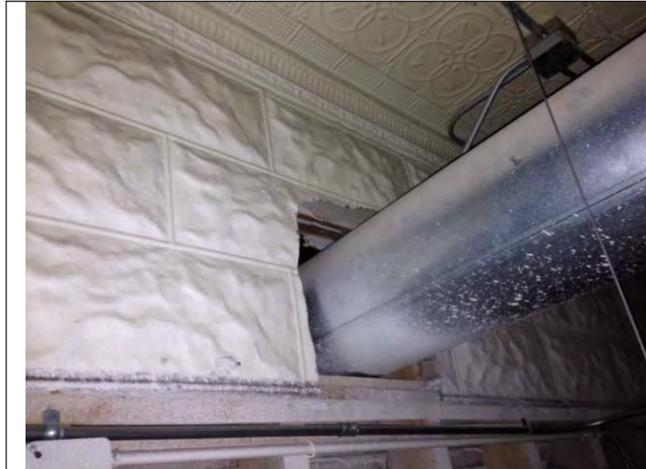
Remains of pressed metal wall tiles above 1881 central corridor

Based on these conditions we recommend that future preservation efforts for the courthouse focus on interpretative displays about the history of the building, which could be centered on the many historic photographs of the building that exist as well as the pressed metal ceilings. Though not as impactful, it is possible that original wood floors exist beneath the carpet areas in the 1881 portion of the building. Revealing these floors in concert with the metal ceilings in selected rooms could evoke the history of the space. Although it would be possible to reveal or recreate some of the other character defining features of the building these endeavors would be costly and in the case of the brick may not be assured of success given the unknown condition.

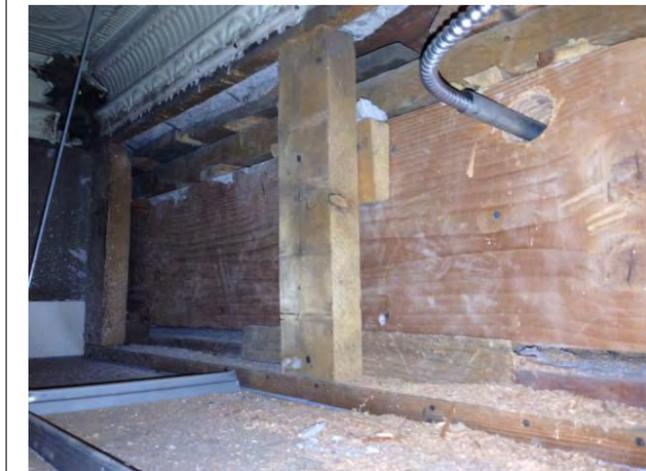
Location of obscured arched-top brick window head

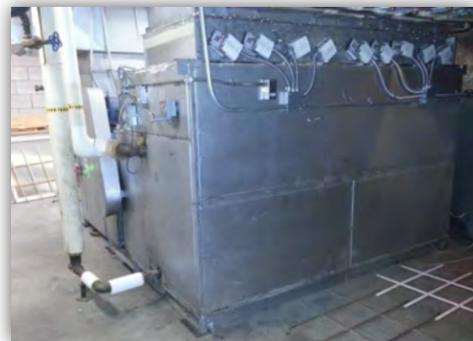
Converted Multizone AHU-1

Air handling unit no. 1 (AHU-1) is located in the basement of the north wing and was converted to a 9 zone multizone unit when the jail addition occurred. The unit has an evaporative cooling section and a hydronic heating coil. The return fan for this unit is an inline fan, which is located next to the unit. The supply air ductwork from this unit was distributed to the north end of the jail addition and to the first and second floor of this addition. The air handling unit was equipped with direct digital controls (DDC) approximately 10 years ago. This unit is more than 20 years old and beyond its mean service life.

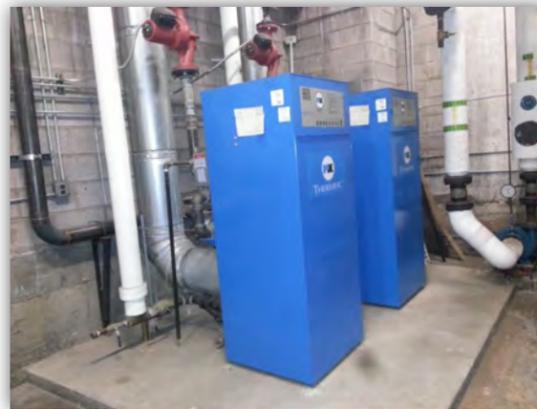
New Boilers

The boiler was replaced in 2002 by two Paterson Kelley Thermific boilers rated at approximately 60 boiler horsepower (BHP). The boilers are piped in parallel, with each boiler having its own boiler circulating pump. The distribution piping from the boilers goes to the system by a parallel pumping system. The boiler pumps and the system pumps are in series which may cause a slight system pressure problem. The boilers and pumps are only 10 years old and have a remaining service life of 10-15 years. It is recommended that VFD's be added to the pumps to make the best use of the pumping system. Located above the water heater is a shell and tube heat exchanger. Water from the boilers passes through the heat exchanger and heats a glycol solution for the garage area snow melting system. The glycol volume is reported to be 30%.

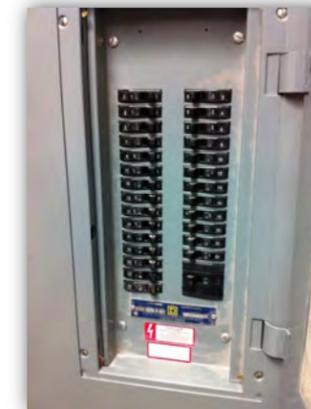
Typical Electrical Panel

The existing 120V and 208V branch circuiting appears to have been replaced, likely during the 1978 addition. All observed wiring was in EMT conduit or installed as MC or AC cable. The observed wiring methods meet current codes, and we anticipate reusing existing wiring where possible.

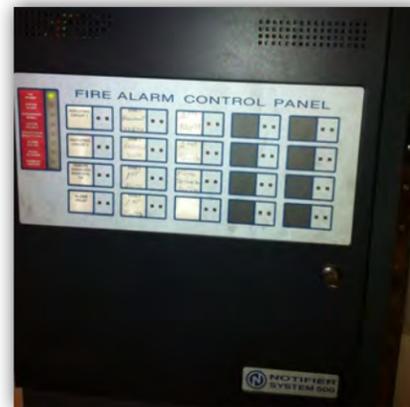
Fire Alarm Control Panel

The existing fire alarm system was manufactured around 1995, and most of the detectors are likely to be out of calibration. Re-calibration can be difficult to achieve, and it is generally more cost effective to replace detectors from this timeframe rather than re-calibrate them. Existing notification horns and strobes would likely need to be relocated to accommodate the future renovation and current ADA requirements. As a result, we recommend that the existing Fire Alarm system be removed and a new Fire Alarm Control Panel, devices, and wiring be installed.
