**ARCHAEOLOGICAL MONITORING OF THE PHASE I OHIO CITY TOWN HALL
(SITE 5GN5833) FOUNDATION STABILIZATION AND HISTORIC REHABILITATION
PROJECT IN GUNNISON COUNTY, COLORADO**

Colorado State Historic Fund Project No. 14-02-026

November 2014

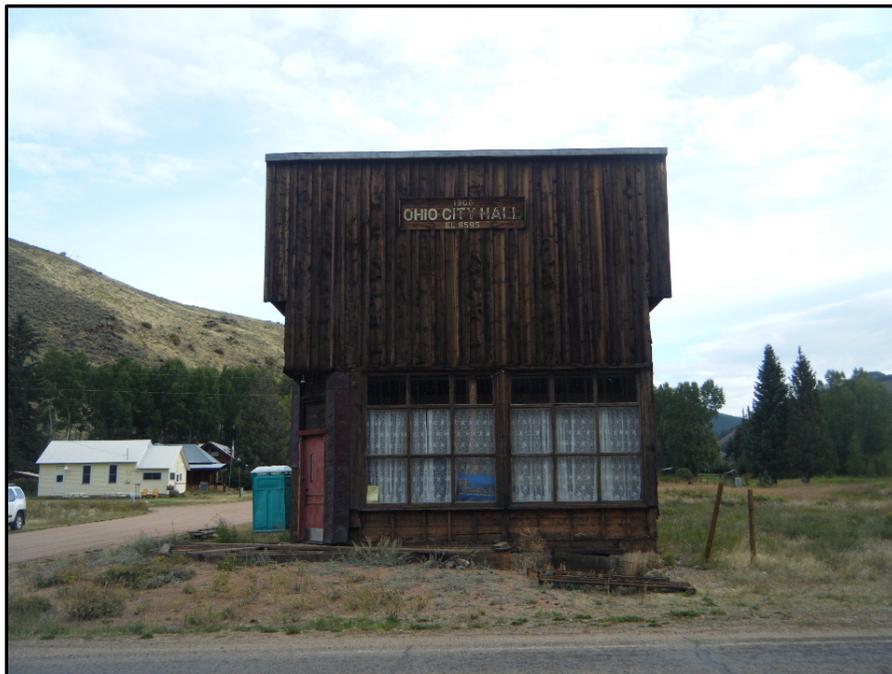
Figure 2. Southern face of Ohio City Town Hall.

has been used for numerous purposes since its inception, including a mercantile, restaurant, town hall, and community center (Figure 2). The reader is referred to the HSA (Humphries Poli Architects 2011) for full background on the Ohio City Town Hall and the historical context for Ohio City, Colorado. Alpine monitored the excavation of small test holes during a structural assessment of the town hall in 2012, as part of the SHF Grant 2010–HA-024 (Mullen 2011). Applicable research questions and topics for historical structures and towns can be found in Church et al. (2007), which provides a Colorado-wide context for historical archaeology.

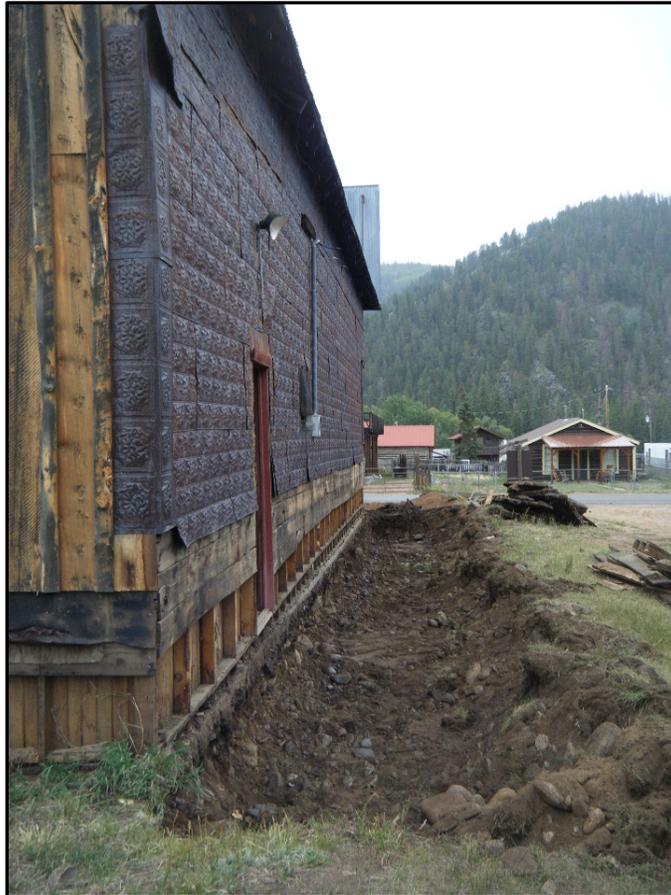
Figure 3. Completed trench along western face of town hall, facing south.

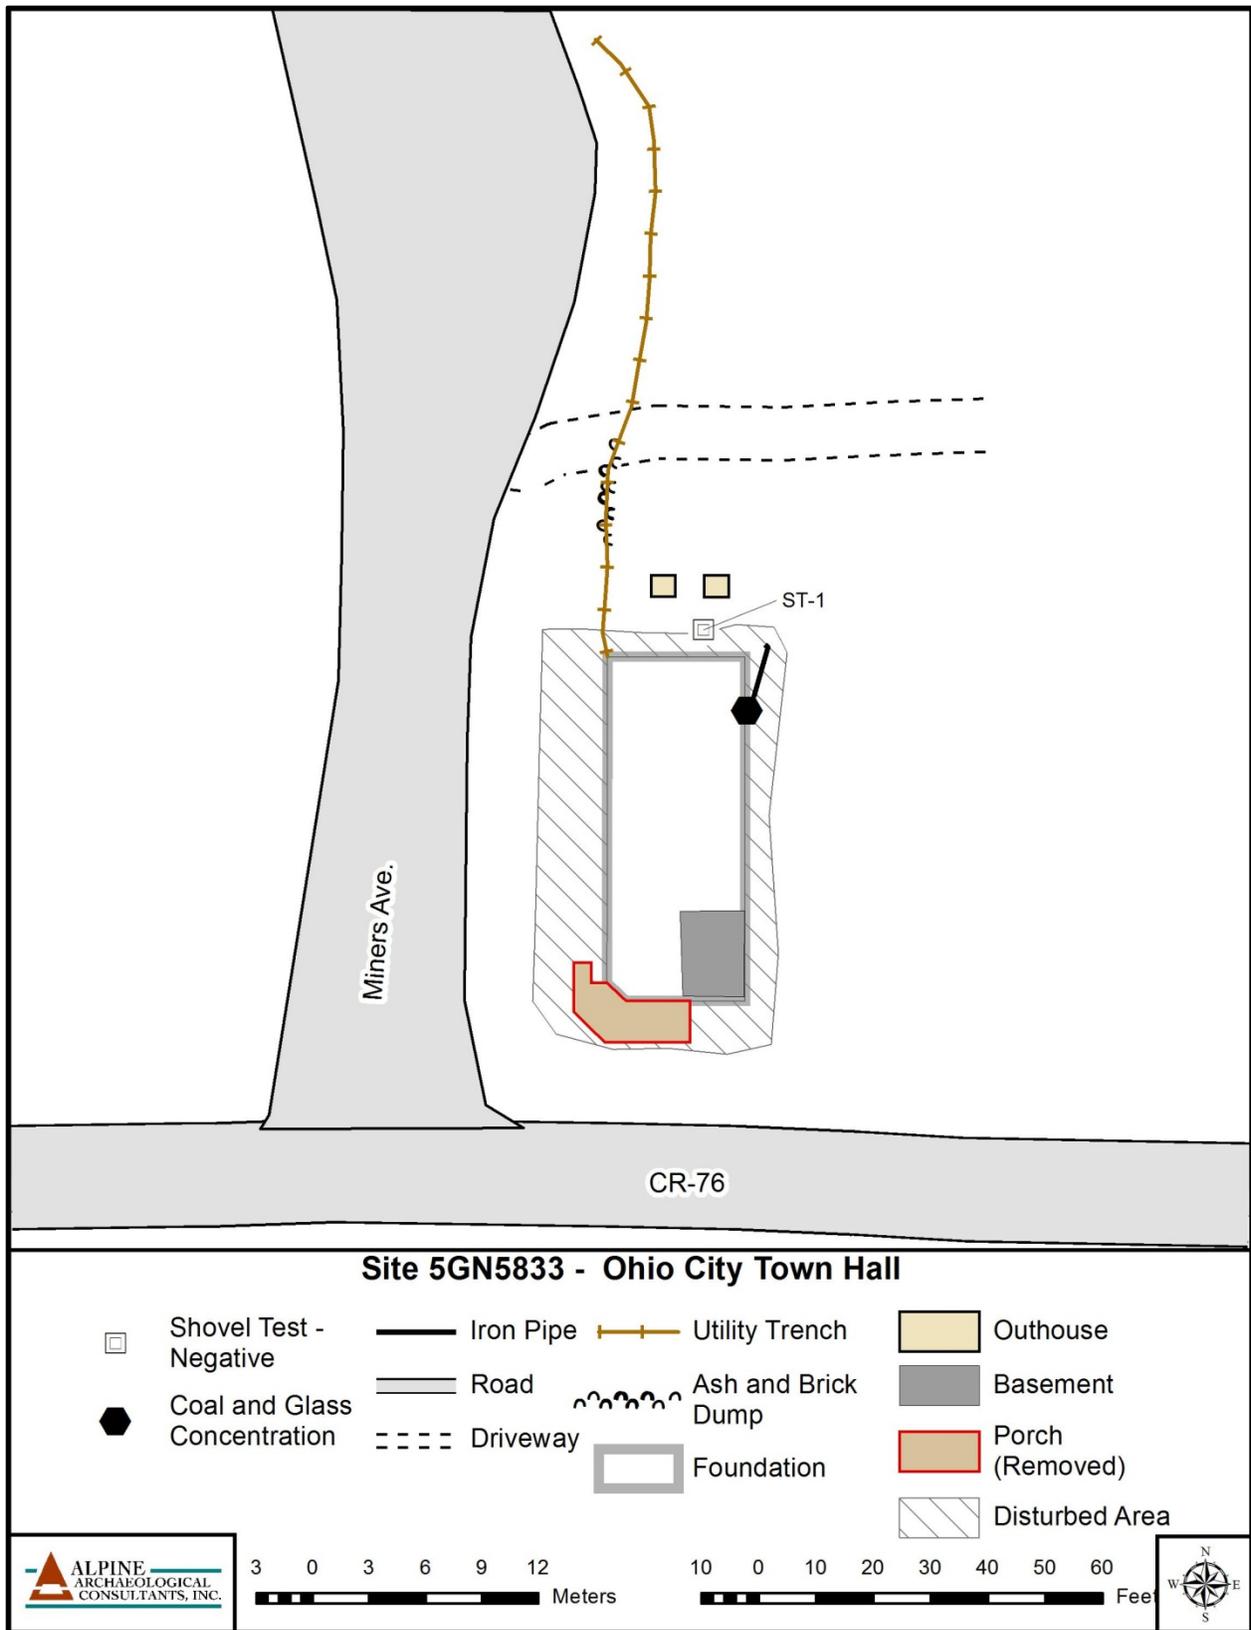
Figure 4. Plan map of monitored work at the Ohio City Town Hall (site 5GN5833).

Alpine monitored ground-disturbing activities at the Ohio City Town Hall on three separate days (Figure 4). Alpine monitored the excavation of two trenches along the eastern and western faces of the building on September 8, 2014. The trenches were excavated on the exterior of the building foundation to allow the building to be lifted and moved to an adjacent lot. The trenches varied between 6 and 8 ft. wide, and between 2 and 3 ft. deep (Figure 3). Alpine returned on September 15, 2014 to monitor the excavation of the area below the building, in advance of the construction of a new building foundation. Excavation for a new foundation resulted in the digging of a 2-ft.-deep foundation area extending slightly 3–6 ft. beyond the building's footprint (Figure 5). This work also included cleaning out an existing, historic basement. Alpine completed monitoring on October 30, 2014 during the excavation of a buried electrical-line trench and the excavation of a footer trench associated with the replacement porch (Figure 6). The utility and footer trenches were between 30 and 42 in. wide, ranged between 2 and 3 ft. deep, and were excavated by a small track hoe operated by a local excavator. Monitoring encountered a variety of historic artifacts centered around the town hall. All of these materials were fairly close to the town hall and were considered a part of the site

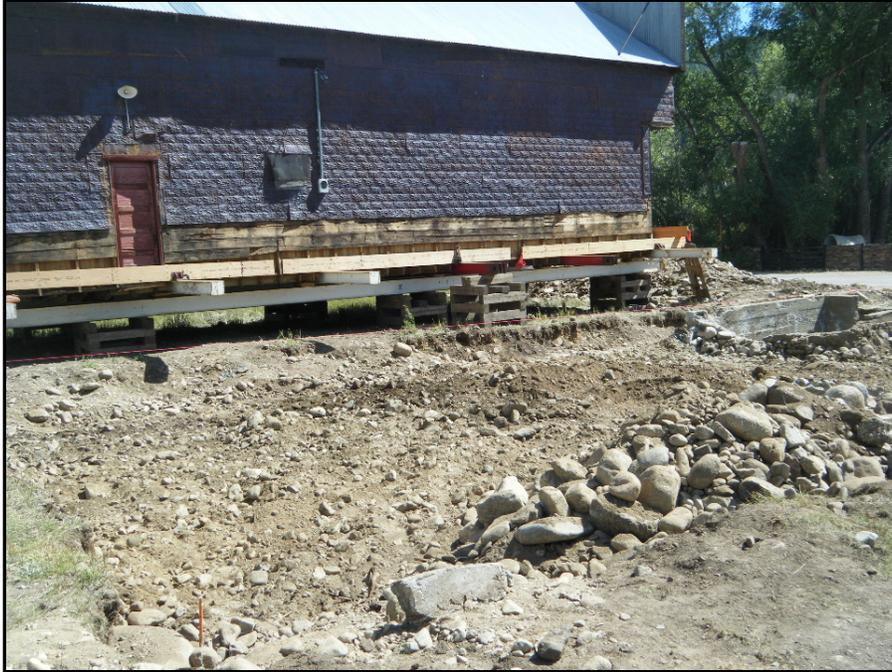
Figure 5. Excavated foundation area after completion of trenching and removal of soil within new foundation area, facing southeast.

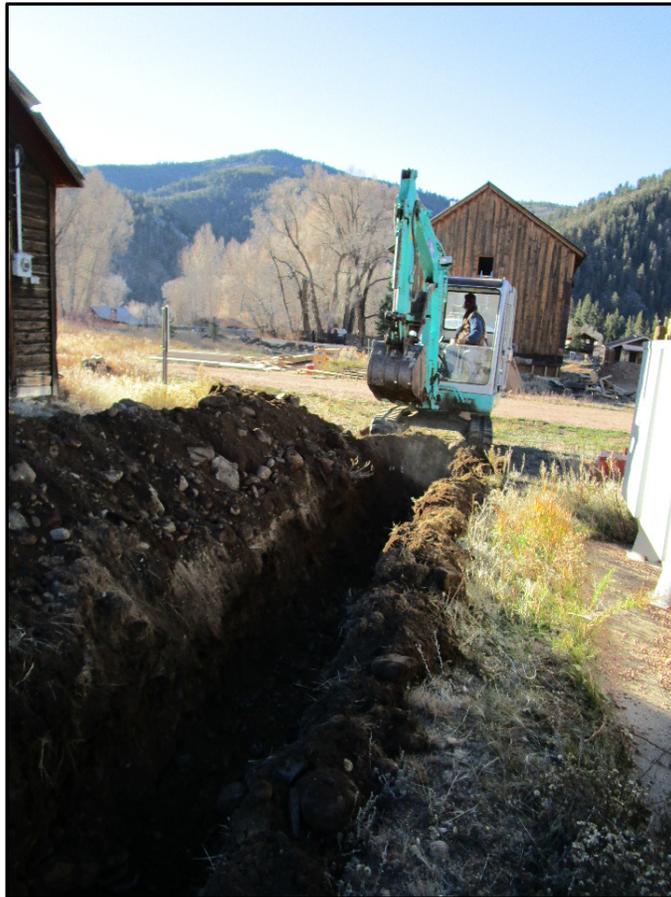
Figure 6. Excavation of the utility trench, facing south.

Almost no artifacts were observed during excavation of the utility-line trench, aside from a concentration of ash, common brick, coal, and a white and red enamelware bowl in a roughly 8–10-ft.-long section of the trench. The bricks did not appear to have been part of an intact and buried feature; given the coal and ash, the concentration appears to represent a buried discard pile. Based on the artifact assemblage observed during monitoring, it is clear that historic use of the area continued, not only from the early 1900s through the 1920s, but up to the early 1960 as well.

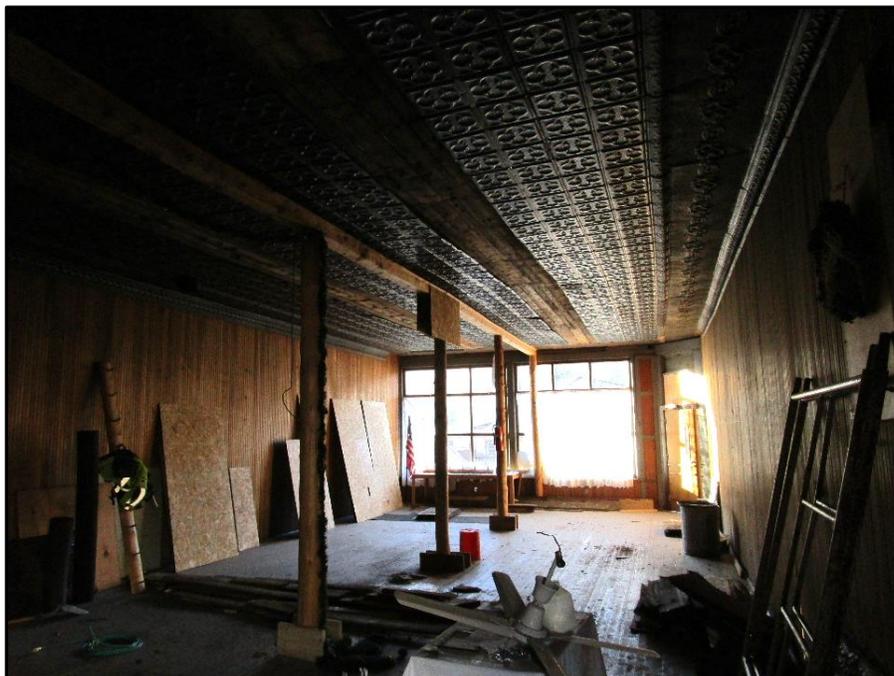
Figure 7. Interior of the Ohio City Town Hall, facing south-southeast.

Alpine revisited the site during the course of monitoring, finding it to largely be as previously documented. A full architectural description of the town hall is available in the HSA (Humphries Poli Architects 2011), with relevant information summarized here. The town hall is a one story, single-room (Figure 7), wood-frame building with ornamental-pressed, terne-plate metal siding on the southern, eastern, and western faces of the building, and wooden board and batten siding on the northern and upper south faces (Humphries Poli Architects 2011). The building is front gabled with a false-front that is constructed of vertical board and batten. Architecturally, the building falls within the False Front Commercial building type. The main, southern facade of the building faces CR-76 and has a store-front array of fixed, wood-sash windows, with the primary entryway at the southwestern corner of the building. An additional entryway is on the northern end of the western side. Aside from the store-front windows, only two other small fixed, wood-sash windows are present on the eastern and western sides of the building. Terne-plate siding on the southern side was only placed below the windows, with most of the front displaying uncovered board and batten. An 11-x-15-ft. poured concrete basement over layered cobbles is below the southeastern portion of the building. The interior walls of the basement are fairly smooth. Fill around the basement is cobbles and soil (see Figure 8).

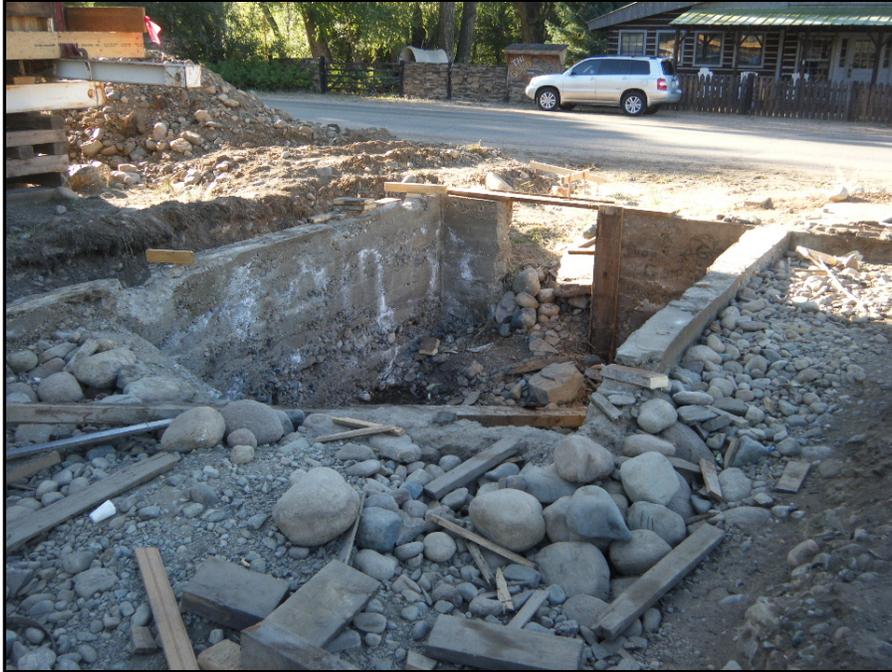
Figure 8. Overview of the basement following the building move, but prior to clean out. View to the southeast. Note the cobble fill around the basement.

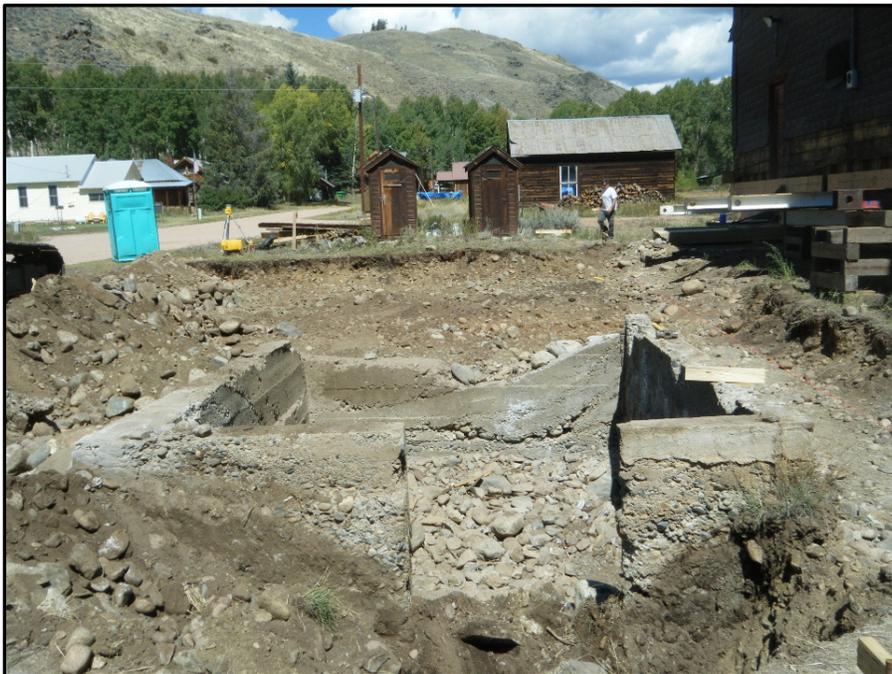
Figure 9. Two outhouses north of the town hall and foundation area, facing north, with the town hall's basement in foreground.

The structure has undergone several modifications since its construction. The roof is covered with galvanized sheet metal, instead of the original shingle roof (Humphries Poli Architects 2011). A modern wooden porch addition at the southern entrance was removed during the course of the project. Two outhouses are present directly north of the town hall. Although in the same wood-frame style as the Town Hall, their exact ages are unknown and it is unclear if they of historic age (Figure 9). Discussion with an Ohio City resident during monitoring suggested that the outhouses may have been given to the community in the 1970s by the U.S. Forest Service (personal communication to Charles Reed, September 15, 2014). The outhouses are still in use.

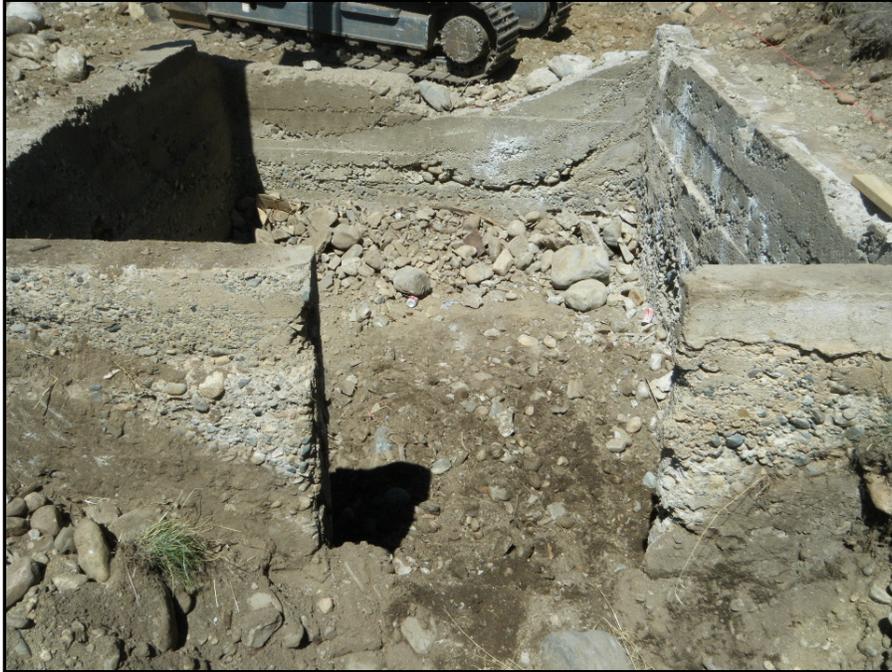
Figure 10. View of the basement following cleaning/removal of refuse and cobbles, facing north.

Aside from the artifact scatter, artifacts were generally of fairly low density, intermixed with modern trash deposited beneath the building and within the basement. The basement contained numerous historic artifacts, including cast-iron pipe collars, Sanitary and hole-in-cap cans, and modern debris, including several pull-tab beverage cans. Along with refuse, the basement was filled with cobbles, gravel, and sediment (Figure 8). It is unclear if the deposition was natural or culturally derived. The rehabilitation and stabilizing work is leaving the historic basement intact, and is being tied into the new foundation (Figure 10).
