INFORMATION SERIES 5

**GEOLOGIC HAZARDS  
IN THE  
CRESTED BUTTE-GUNNISON  
AREA  
GUNNISON COUNTY, COLORADO**

BY  
JAMES M. SOULE

COLORADO GEOLOGICAL SURVEY  
DEPARTMENT OF NATURAL RESOURCES  
STATE OF COLORADO  
DENVER, COLORADO

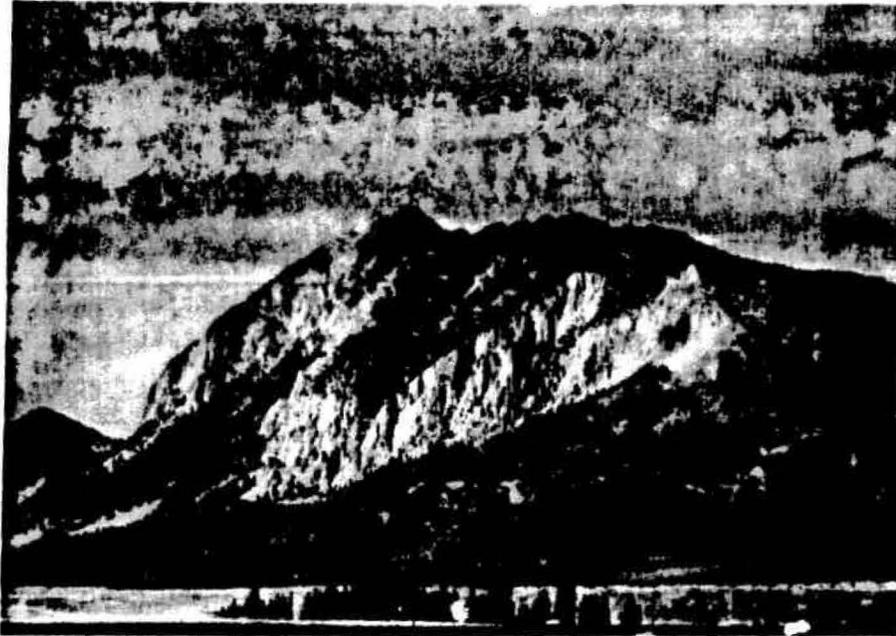
*FIGURE 2. Crested Butte Mountain from Cement Creek-East River confluence. View to northwest. Note that lower slopes have subdued topography that is composed of Mancos Shale or rockstreams from higher slopes. Mountain is held up by a laccolith-like body of quartz-monzonite porphyry. (200-mm lens)<sup>1/</sup>*

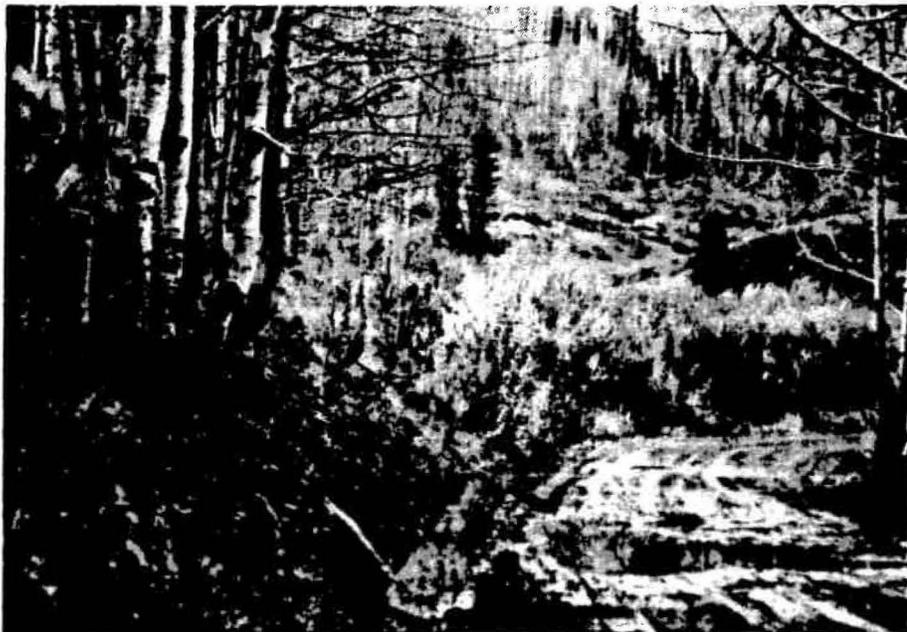
*FIGURE 3. The slope to the left of the road is failing rapidly as evidenced by the curved trunks of the aspens. Note water on road that results from leakage of excess soil moisture from slope at left. (105-mm lens)*

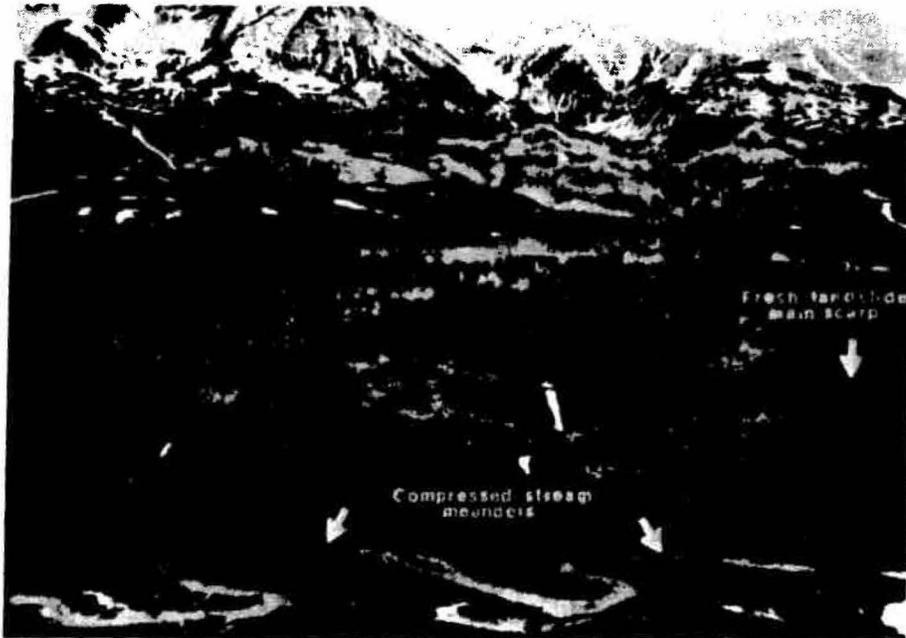
FIGURE 7. Active landslide area: Obvious evidence for landsliding indicated on photograph. Upper East River area south of Gothic. (105-mm lens)

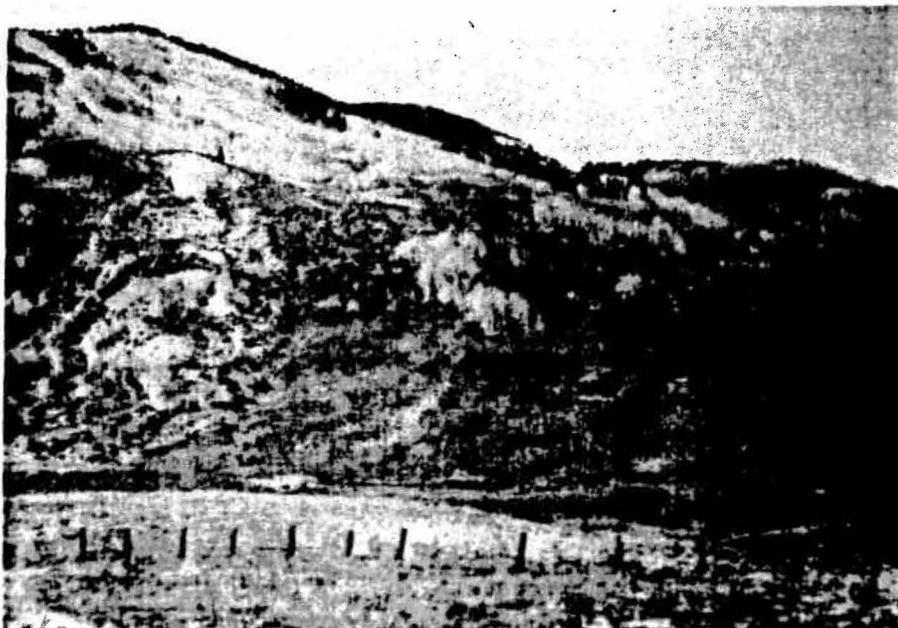
FIGURE 8. Recent landslide on southeast slope of Snodgrass Mountain. The entire side slope here is a complex of landslides. (105-mm lens)

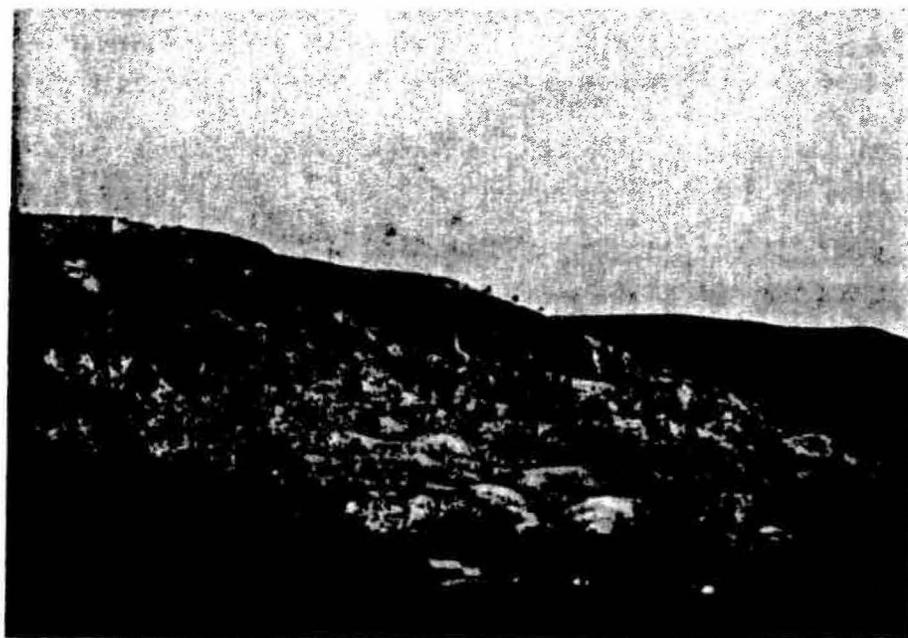
*FIGURE 9. Landslide area north-northwest of Gunnison. This is a relatively recent case of large-scale land-sliding that involves the West Elk Breccia. (105-mm lens)*

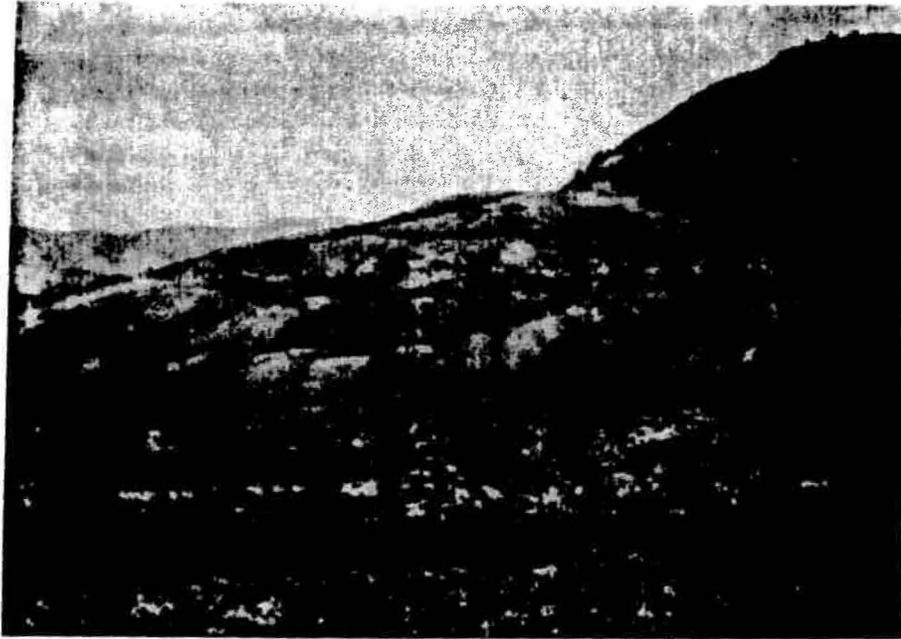
*FIGURE 10. Older stabilized landslides north-northwest of Gunnison involving West Elk Breccia. (105-mm lens)*

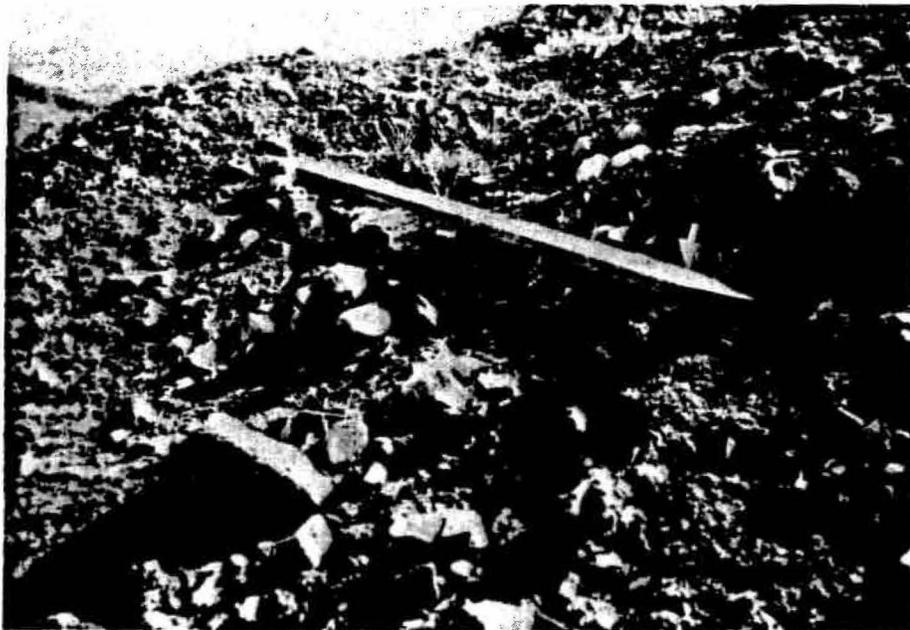
*FIGURE 12. Unstable slope-forming materials composed of admixed Mancos Shale colluvium and glacial drift. Such materials as this tend to be unstable on moderate to very steeply sloping ground as they are permeable and have little cohesion. Arrow points to "2 x 4" lumber. (35-mm lens)*

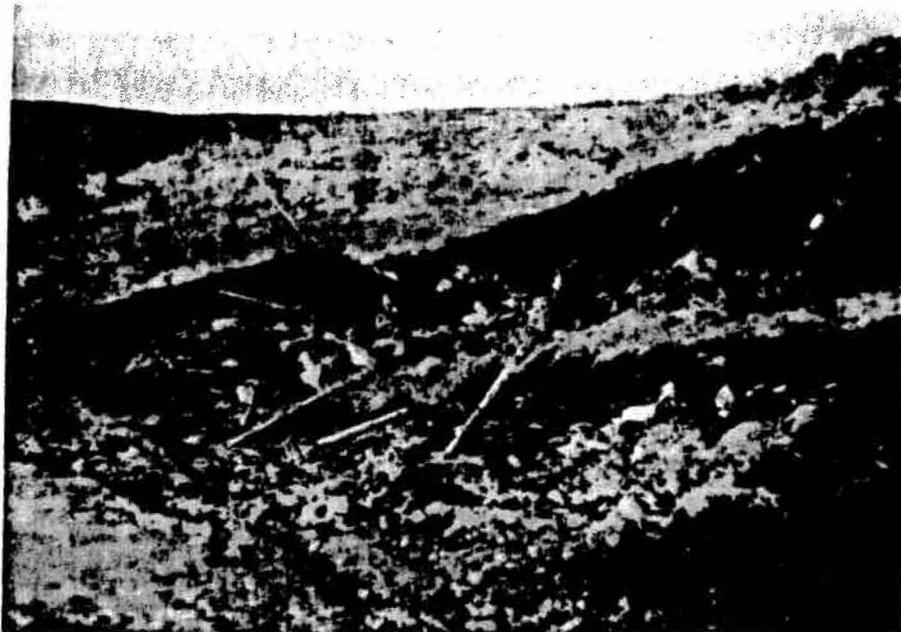
*FIGURE 13. Small slope failure in roadcut. These are common in many places where steep cuts have been made into potentially unstable or unstable slopes. Arrow points to fencepost approximately 4 ft (1.3 m) high. (35-mm lens)*

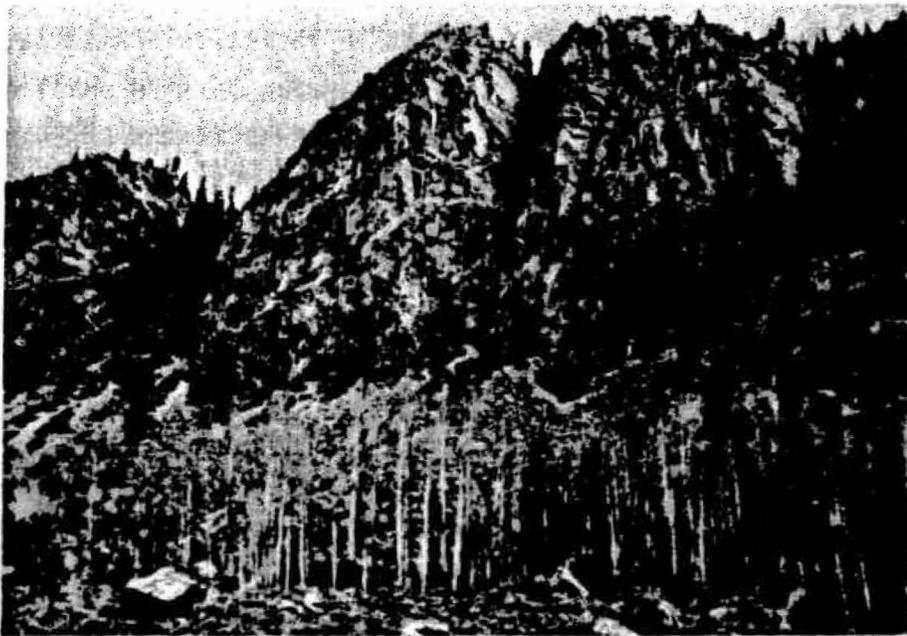
*FIGURE 14. Rockfall area in Taylor Canyon. Note large rock fragments in foreground that rest on nearly level ground (35-mm lens)*

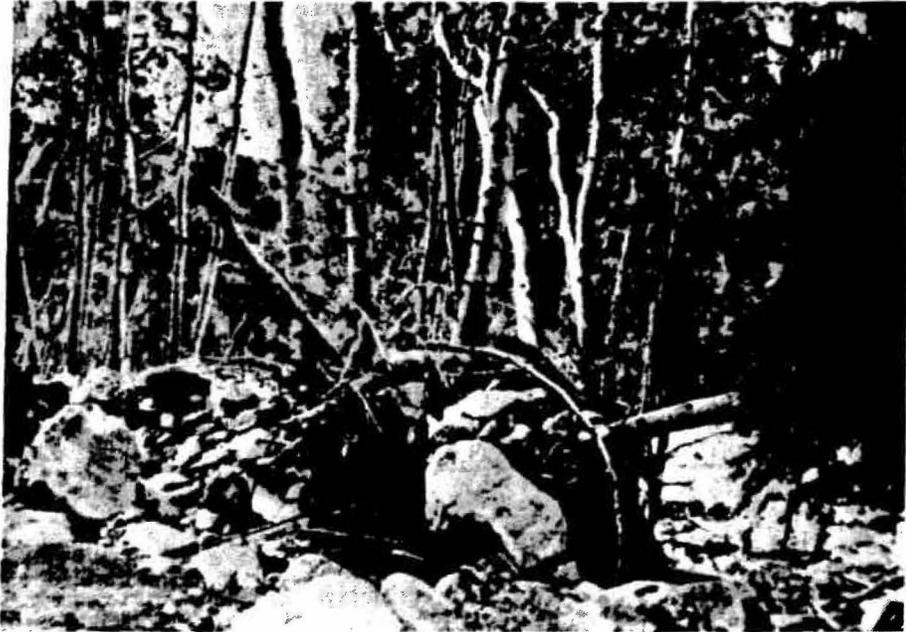
FIGURE 16. Mudflow material. Note sizes of rock fragments and debris caught by trees, probably during the initial flood surge of the mudflow. (35-mm lens)

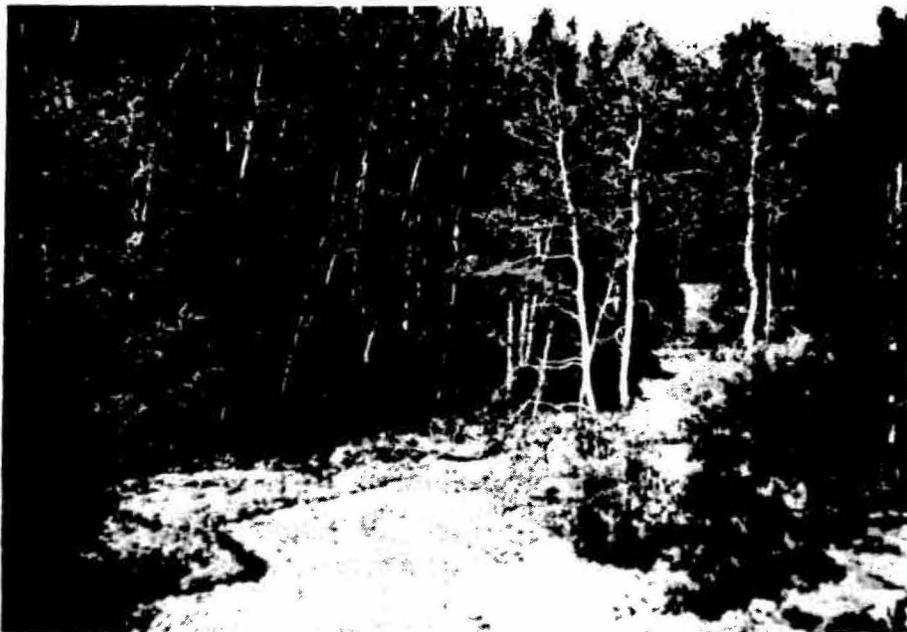
FIGURE 17. Typical small mudflow. Upper Ohio Creek area. (35-mm lens)

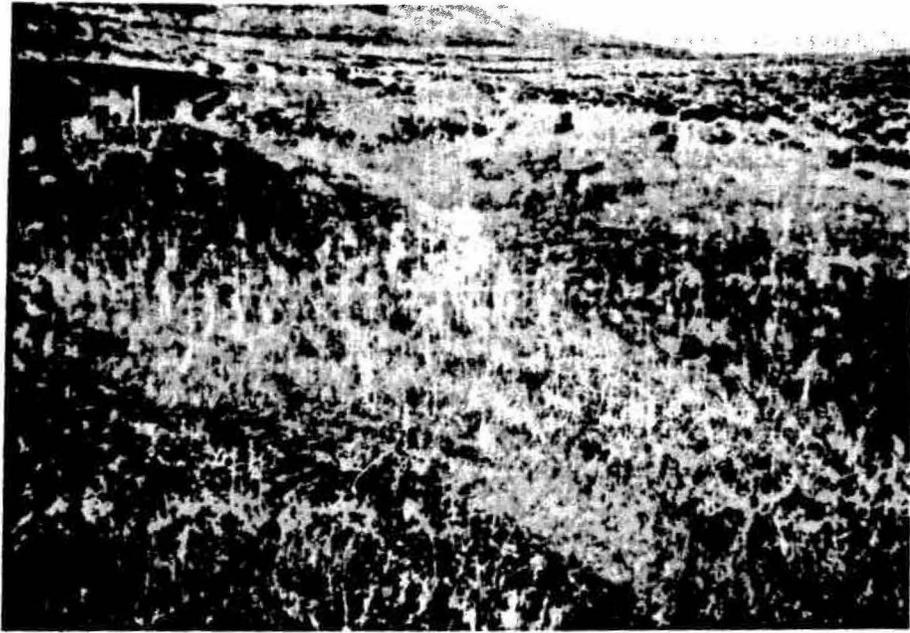
*FIGURE 20. Evidence in vegetation that this area has increased soil moisture. Note sagebrush in distance. Also note the hummocky ground indicative of probable small-scale earth flowage. Arrow points to stake approximately 1 ft (.3 m) high. (35-mm lens)*
